## Red Oak - No. 43 Taupahi Road

To: Greg Hadley (Taupō District Council)  
CC: Andrew Moor (Taupō district Council)  
From: Adrian Lamont (Arb-Eco Limited)  
Subject: Red oak outside no.43 Taupahi Road, Turangi

27 November 2024

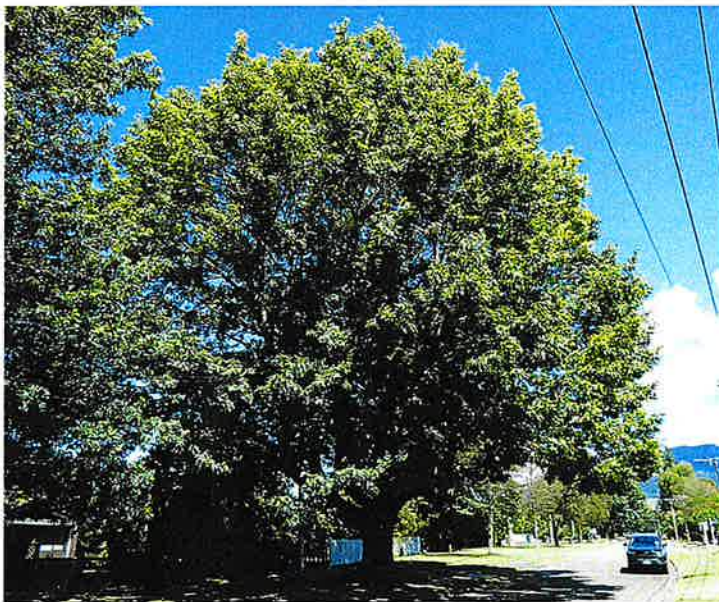
Prior to tree works (Feb 2024)

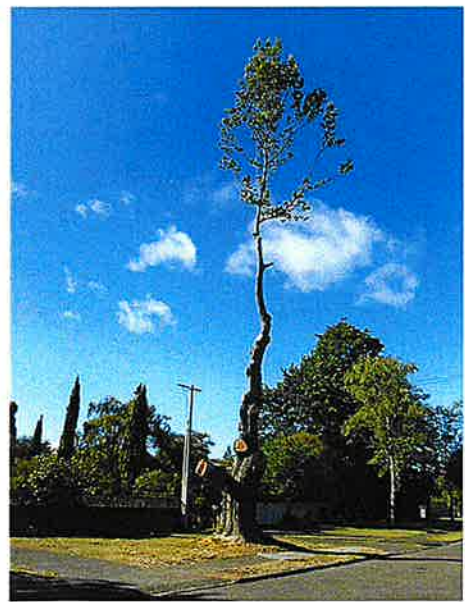
Following tree works (22 Nov 2024)

4. Unfortunately, work continued on the tree until the entire scaffold branch structure had been removed, leaving the tree with only a tiny fraction of its original foliar cover. Furthermore, the works were carried out without regard to minimising damage (as would be expected while removing a tree). As a result saw cuts were not made in accordance with accepted pruning techniques, causing branch tears and flush cuts which have damaged wood fibres within the remaining stem.

13. In my opinion the most pragmatic option is to complete the removal of the tree and, at a minimum, plant a large grade replacement of the same species in this location in order to promote the long-term integrity of the avenue of along Taupahi Road of which it is part. There are further locations available along the road where other trees from the avenue have been lost which are also suitable for infill / replacement planting. This would provide additional mitigation and help restore and maintain the avenue.

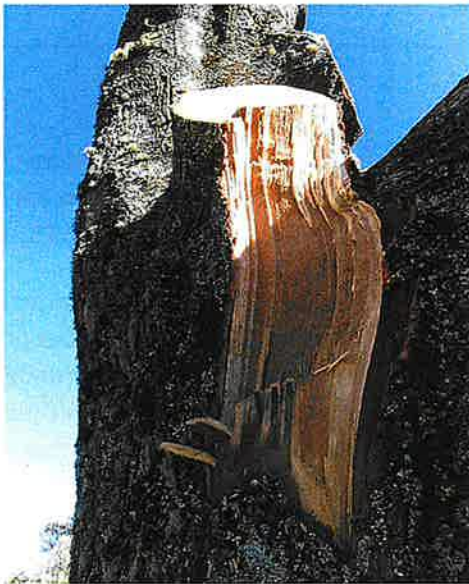
Branch tear

not be well adapted to being left totally exposed. In the longer term there is very likely to be significant decay ingress via the numerous large wounds that have been created all up the stem. Combined with dense new epicormic growth and the additional weight and wind drag, this with further increase the risk of stem failure.

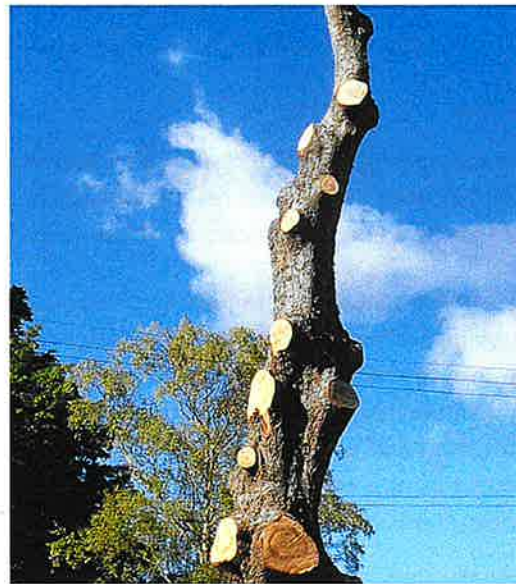
Flush cuts

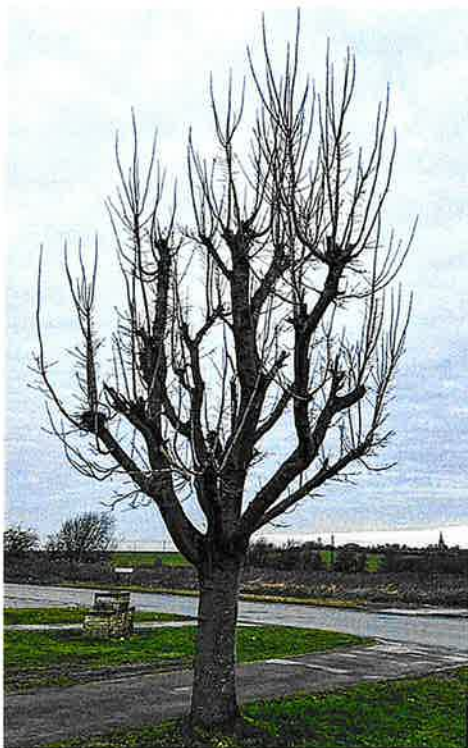
Structure of a typical pollarded tree.

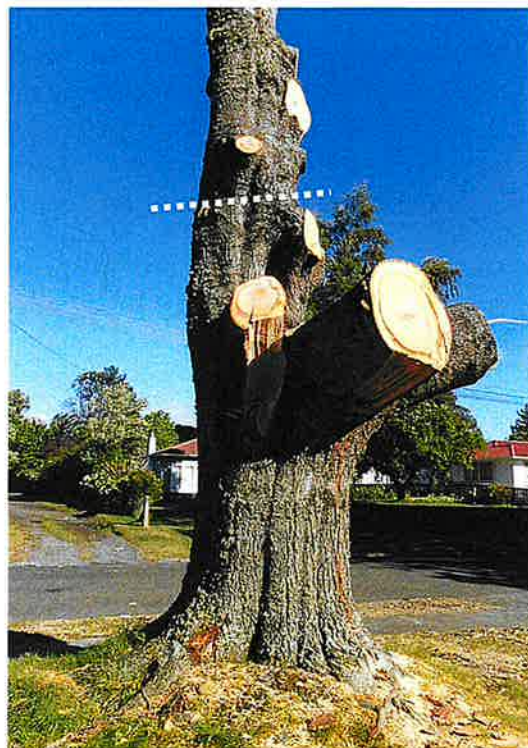
Remaining structure of the subject tree (after removal of remaining stem).

10. For these reasons, in my opinion this is not likely to be successful or worthwhile, as the tree lacks sufficient remaining branch structure. Even with many years of careful annual pruning to re-establish a reduced branch framework there would be no realistic prospect of then allowing the tree to grow on to anything like its original stature. The bole and remaining stubs are very likely to be extensively decayed by that time and unable to safely support an extensive crown. Accordingly the tree would need to be maintained indefinitely to restrict its growth, weight and wind drag.

11. For the reasons provided above, in my opinion neither of the two options for tree retention are appropriate or likely to be cost effective or practical. This leaves full tree removal as the most viable option. Replacement planting of a large grade, good quality specimen of this species in the same location, as well as appropriate aftercare, will be the most cost effective means of mitigating the loss of amenity and is likely to be most beneficial on the long run as it will provide for a good quality tree capable of being retained in a safe condition for the long term.
