**Asbestos Re-inspection Of**

**72 Lake Terrace,, Taupo, 3330**

Report Reviewed and Authorised I By Mike Sullivan	
Position:	
Project Number: 17-035894	Issue Date: 15/05/2017

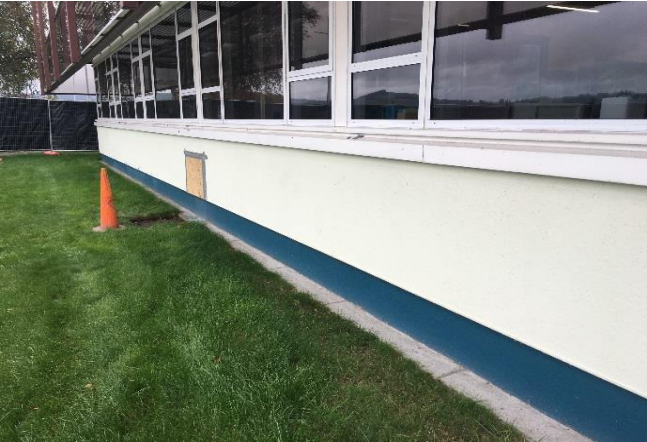
Room/Area: Floor E, Room E (Externals To Original Building)
	Description: Wall cladding at low level (Fibre cement) - 17-035894-01
	Sample Identifier: 17-035894-01
	Result: Chrysotile Crocidolite
	Notes:
Recommendations: Re-inspect periodically and maintain paint finish

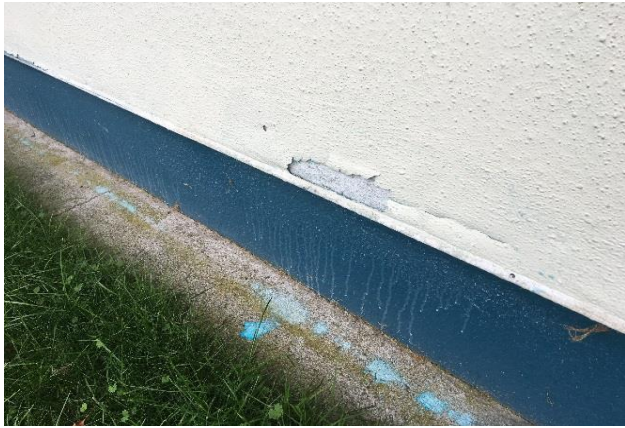
Room/Area: Floor E, Room E (Externals To Original Building)
	Description: Wall cladding at low level (Fibre cement) -As 17-035894-01
	Sample Identifier: As 17-035894-01
	Result: Chrysotile Crocidolite
	Notes: Paint flaking off with exposed edges
Recommendations: Remove by a licensed contractor at low level where damage has occurred

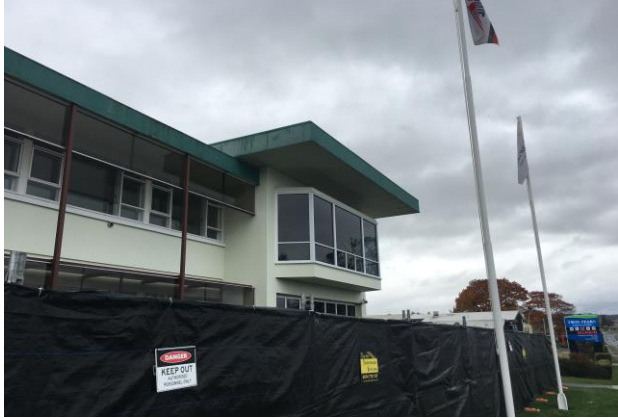
<p>A photograph showing the exterior of a building with high-level wall cladding. The building has a green roof and a balcony. A black tarp is in the foreground with a 'KEEP OUT' sign. Two flagpoles are visible against a cloudy sky.</p>	<p>Room/Area: Floor E, Room E (Externals To Original Building)</p>
<p>Description: Wall cladding at high level (Fibre cement) - As 17-035894-01</p>	
<p>Sample Identifier: As 17-035894-01</p>	
<p>Result: Chrysotile Crocidolite</p>	
<p>Notes:</p>	
<p>Recommendations: Re-inspect periodically and maintain paint finish</p>

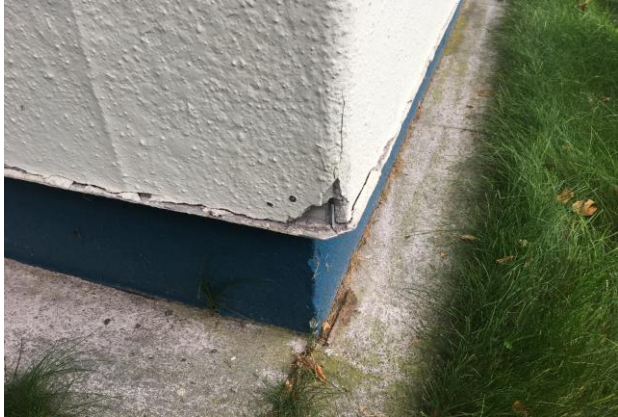
<p>A close-up photograph of the corner of a building where the white wall cladding meets a blue base. There is visible damage and peeling of the cladding at the bottom corner. A concrete path and grass are visible in the foreground.</p>	<p>Room/Area: Floor E, Room E (Externals To Original Building)</p>
<p>Description: Wall cladding at low level to left side (Fibre cement) - As 17-035894-01</p>

<p>Sample Identifier: As 17-035894-01</p>	
<p>Result: Chrysotile Crocidolite</p>	
<p>Notes:</p>	
<p>Recommendations: Remove by a licensed contractor at low level where damage has occurred</p>

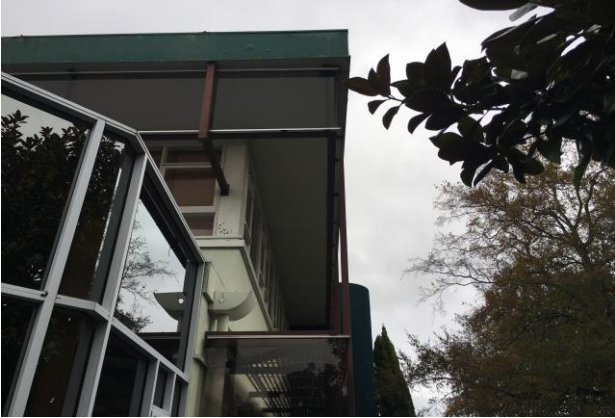
<p>Room/Area: Floor E, Room E (Externals To Original Building)</p> <p>Description: Soffits and eaves to all sides of original building (Fibre cement) - 17-035894-01sp</p> <p>Sample Identifier: 17-035894-01sp</p> <p>Result: SP Chrysotile (strongly presumed)</p> <p>Notes: Paint flaking off in various areas throughout, Previously sampled by 3rd party</p> <p>Recommendations: Encapsulate with paint and Re-inspect periodically</p>

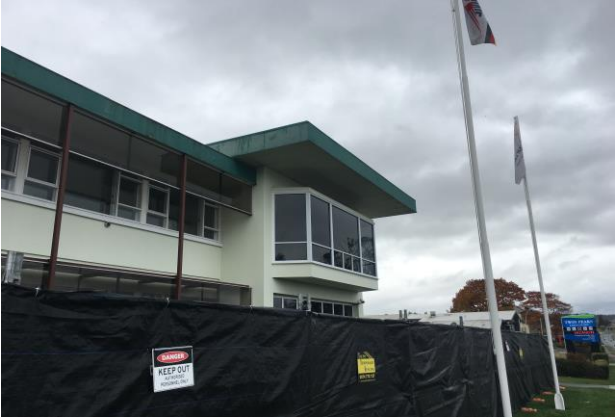
<p>Room/Area: Floor E, Room E (Externals To Original Building)</p> <p>Description: Soffits and eaves to all sides of original building (Fibre cement) - 17-035894-01sp</p> <p>Sample Identifier: 17-035894-01sp</p> <p>Result: SP Chrysotile (strongly presumed)</p> <p>Notes: Paint flaking off in various areas throughout, Previously sampled by 3rd party</p> <p>Recommendations: Encapsulate with paint and Re-inspect periodically</p>

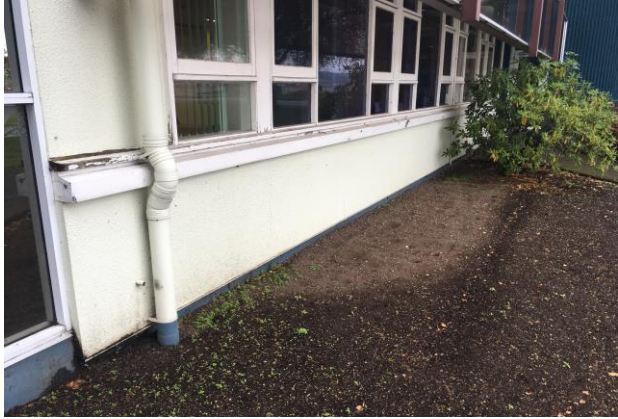
Room/Area: Floor E, Room E (Externals To Original Building)
	Description: Coating to walls on all sides of original building (Textured coating) - 17-035894-02sp
	Sample Identifier: 17-035894-02sp
	Result: SP Chrysotile (strongly presumed)
	Notes: Previously sampled by 3rd party
	Recommendations: Encapsulate damaged areas with paint and Re-inspect periodically

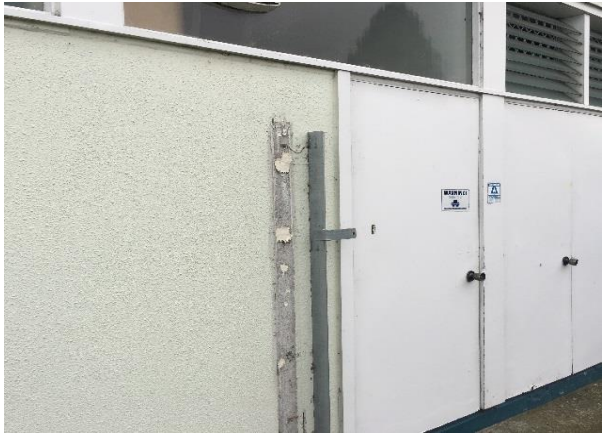
Room/Area: Floor E, Room E (Externals To Original Building)
	Description: Coating to walls on all sides of original building (Textured coating) - 17-035894-03sp
	Sample Identifier: 17-035894-03sp
	Result: SP Chrysotile (strongly presumed)
	Notes: Previously sampled by 3rd party
	Recommendations: Encapsulate damaged areas with paint and Re-inspect periodically
