Project Number: 2-38030.00

# Taupō Industrial Plan Change

## Preliminary Desktop Geotechnical Assessment

15 September 2022

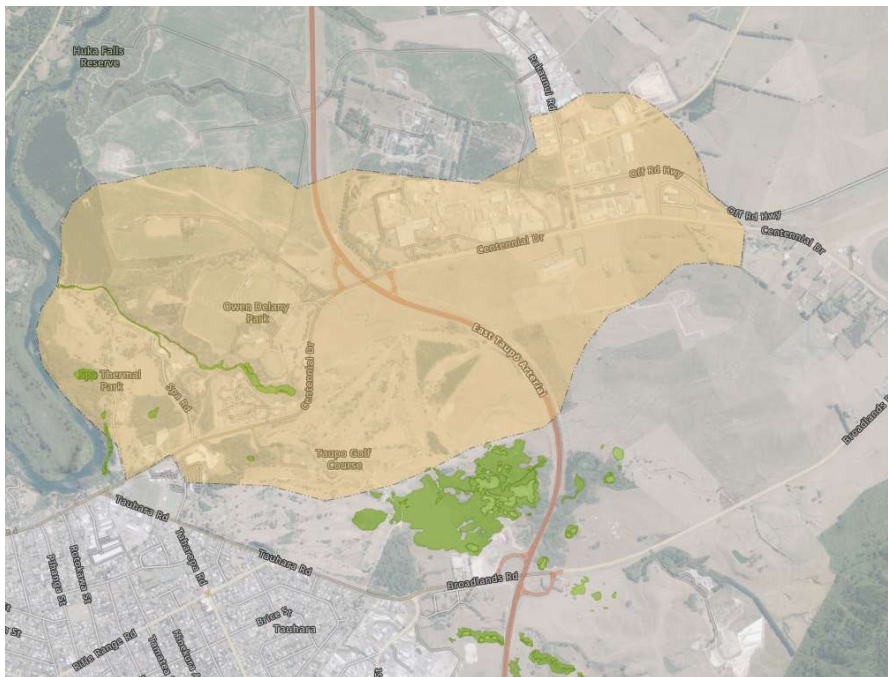
Figure 2: Geothermal subsidence bowl (orange) and geothermal habitats (green), (ref: Waikato Regional Hazards Portal)

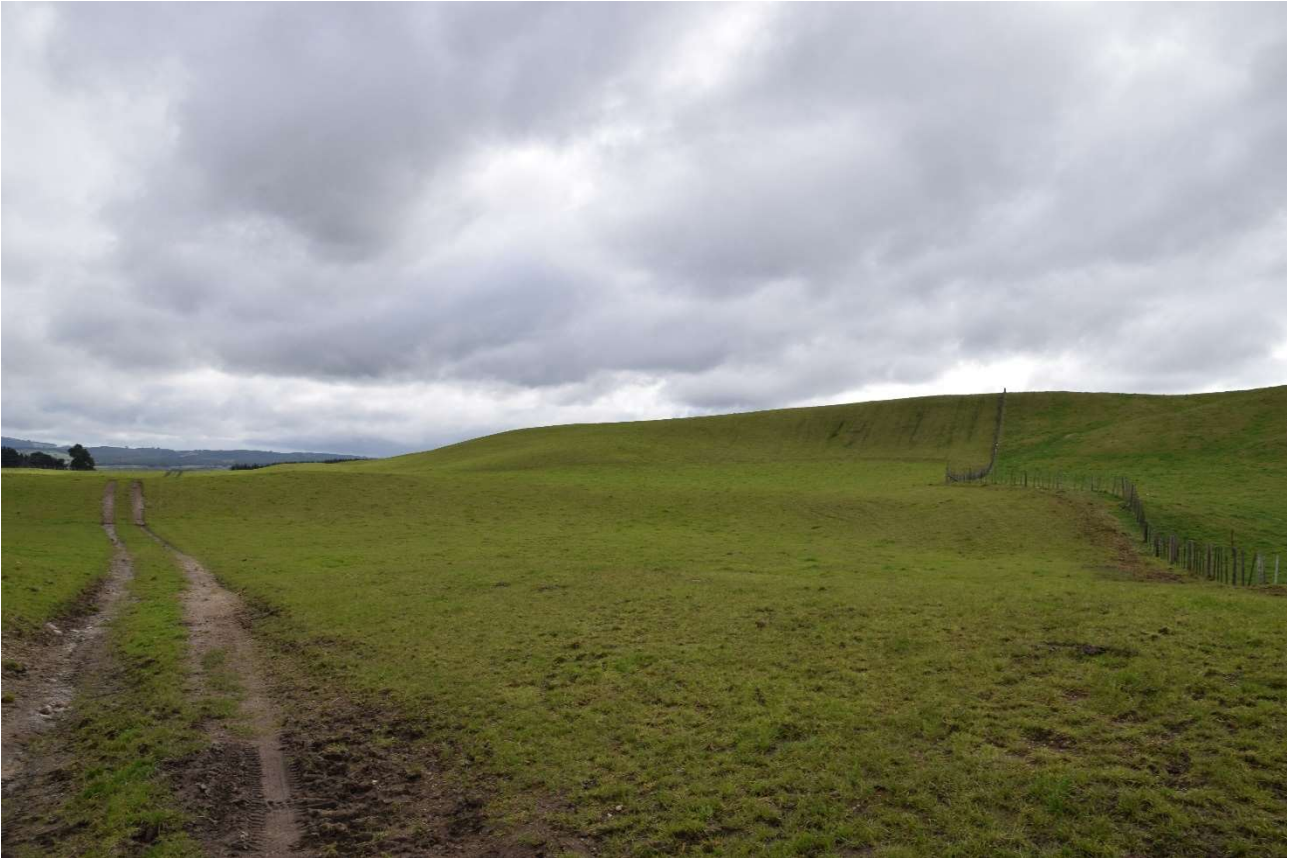
Slope instability was not identified as a risk in the desktop assessment, however the rolling hills observed during the site walkover along the eastern property boundary do indicate stability issues to be considered. Some shallow erosional scars were observed but no evidence of large-scale or deep seated instability were observed. Quantitative stability analysis will be required to inform any modification in and around the hills as part of future development.

*Figure 2: View roughly northwest, with rolling hill to the right*

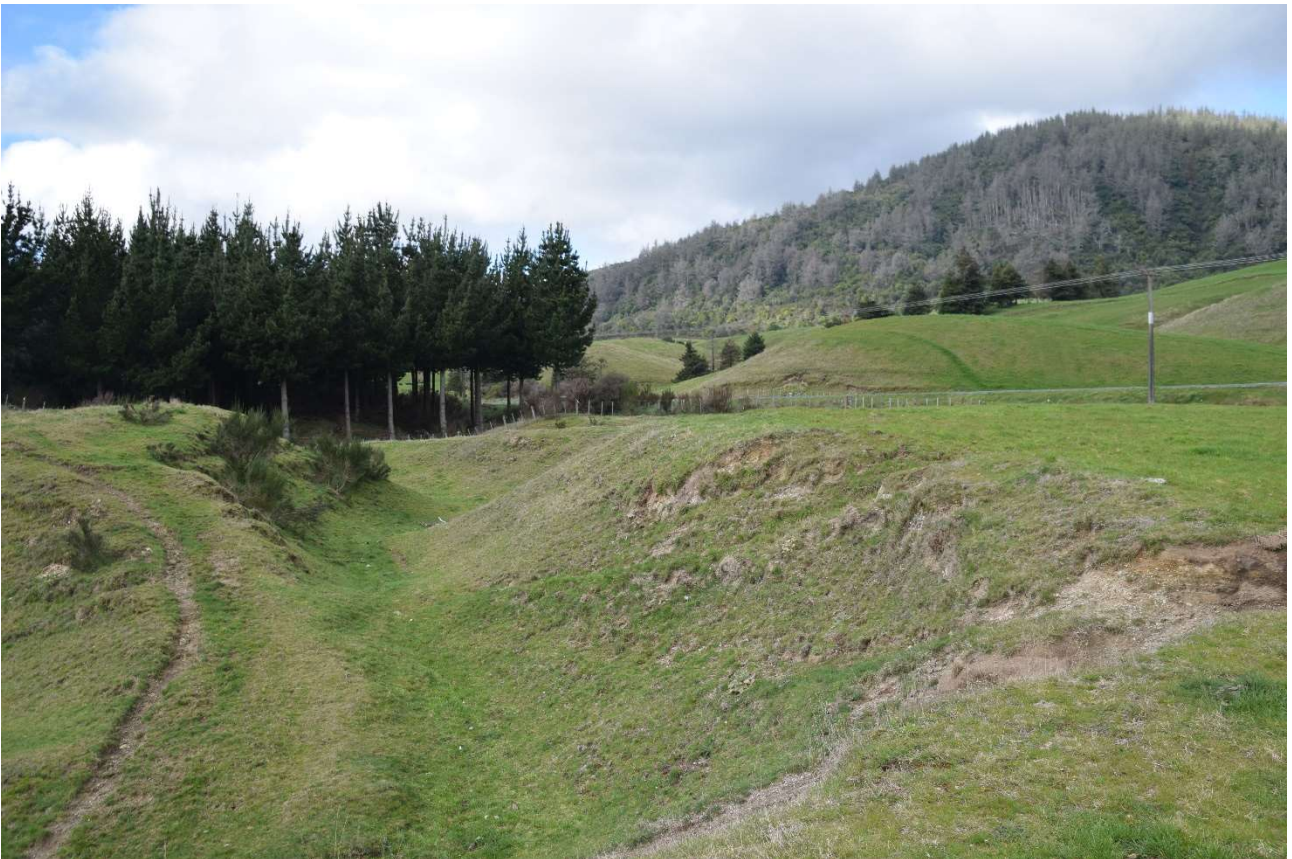
*Figure 3: Example of localised instability due to erosional issues*

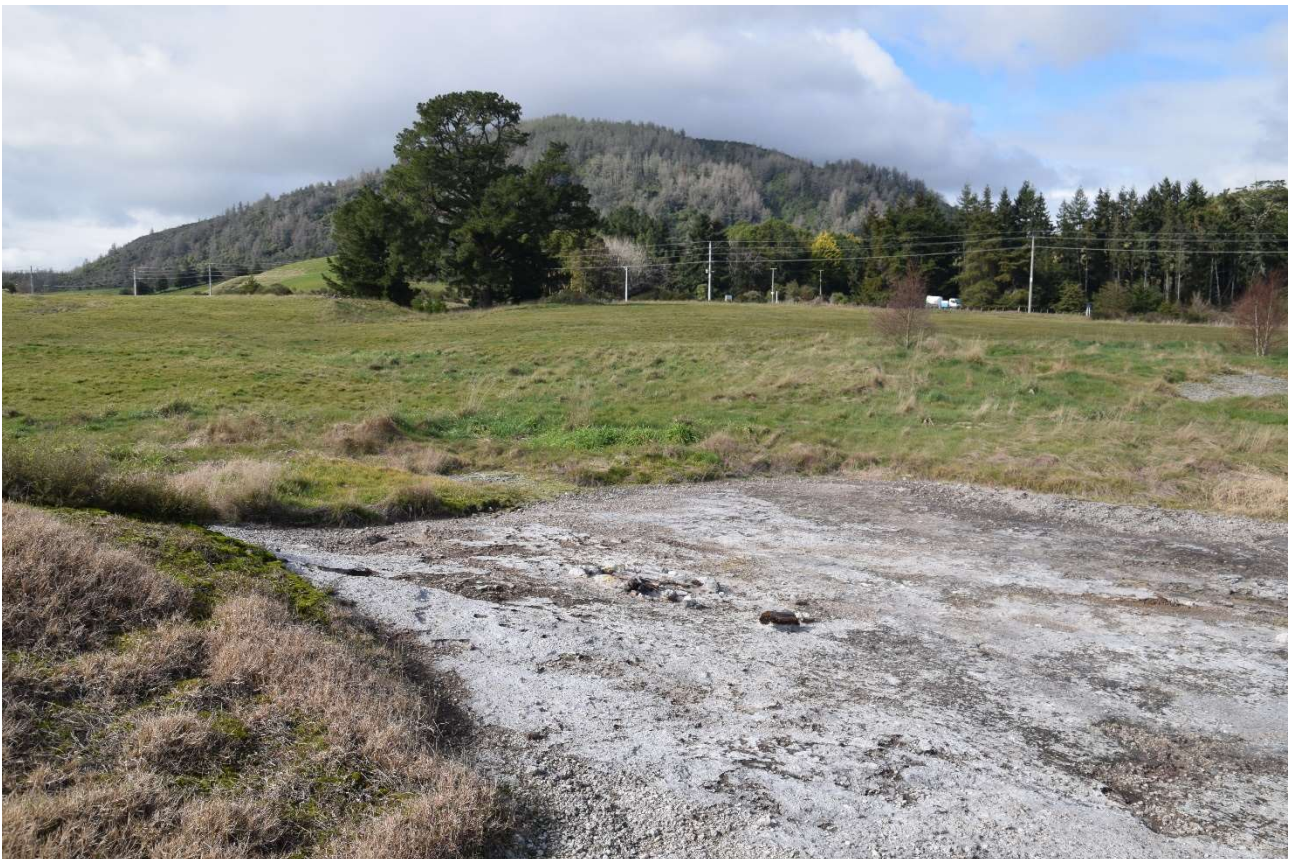
Expression of geothermal activity at ground surface was identified outside the area designed as the 'Hot Ground Hazard Area'. The walkover confirmed the presence of hot ground in the centre of the site, where possible vents were identified on aerial photography. Steam was not venting at the time of the site walkover but the ground was warm to touch and no vegetation was growing in the area. Hot ground will need to be investigated and development should be excluded where geothermal activity is expressed at ground surface. Ground temperature readings during geotechnical investigation will be required to determine how far the hot ground hazard extends beyond the perimeter of the mapped hazard area. Specialist assistance from GNS should be sought to better quantify what may happen with these features in the future,

*Figure 4: Example of hot ground present towards the centre of the site*

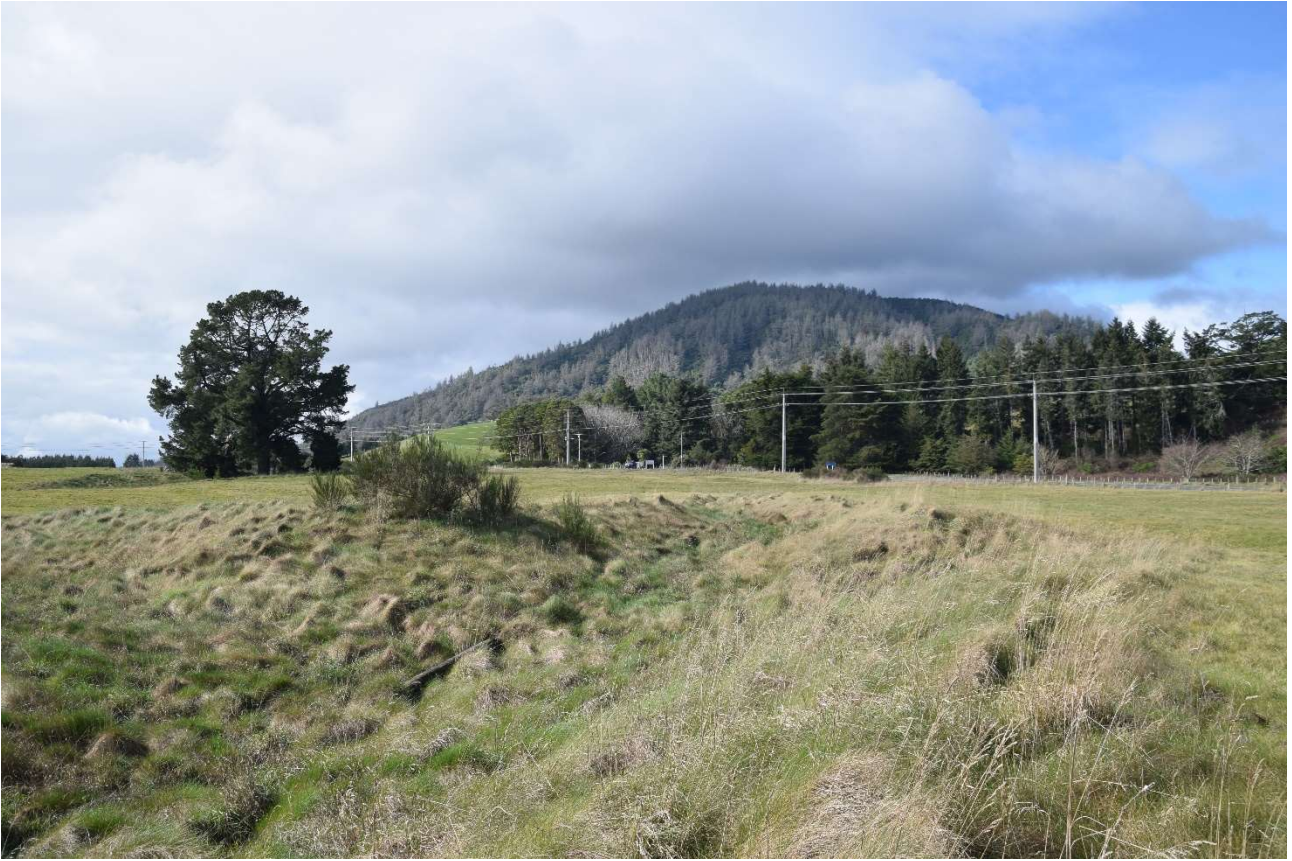
*Figure 5: Shallow gully that flows approximately east to west, towards hot ground hazard area. Broadlands Road and Mt Tauhara can be seen in the distance.*

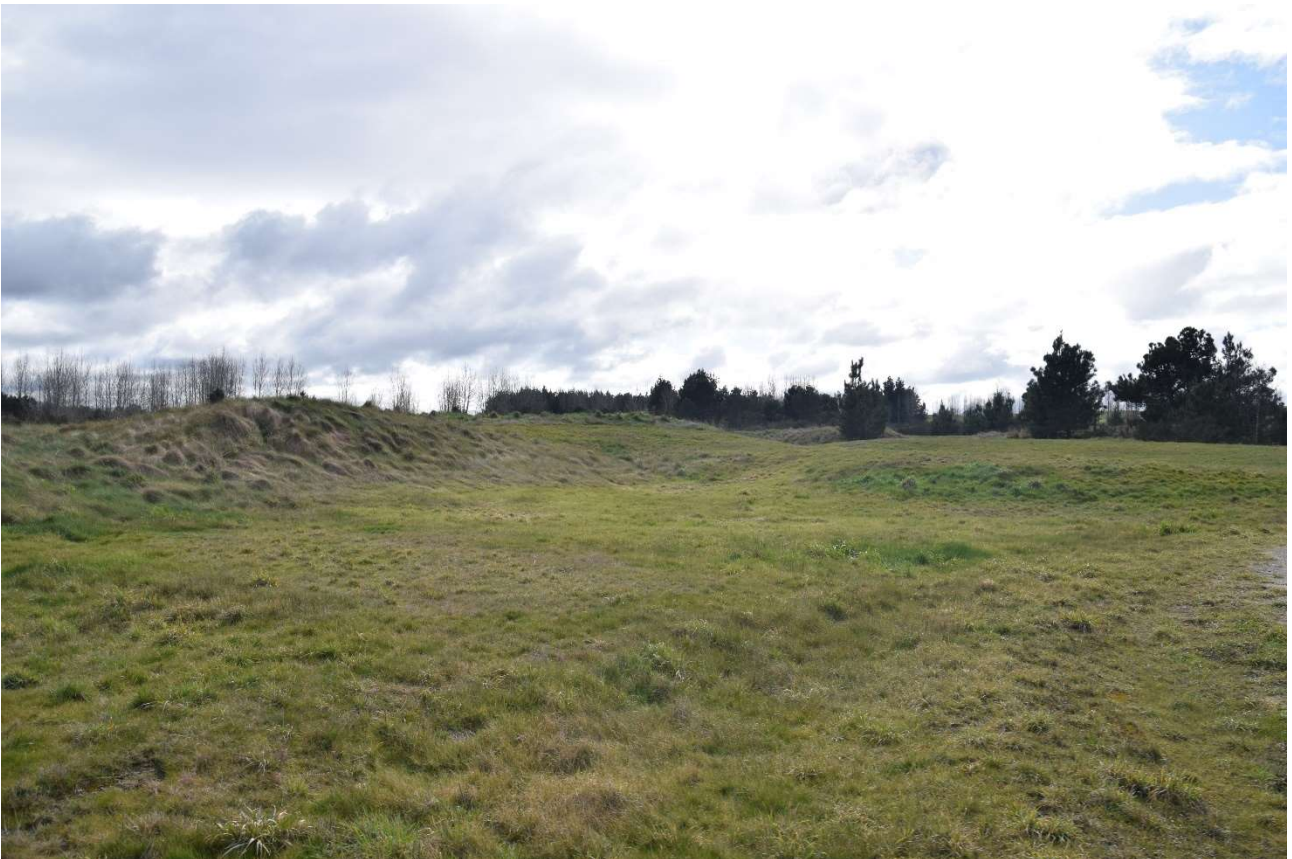
*Figure 6: General form of the land*

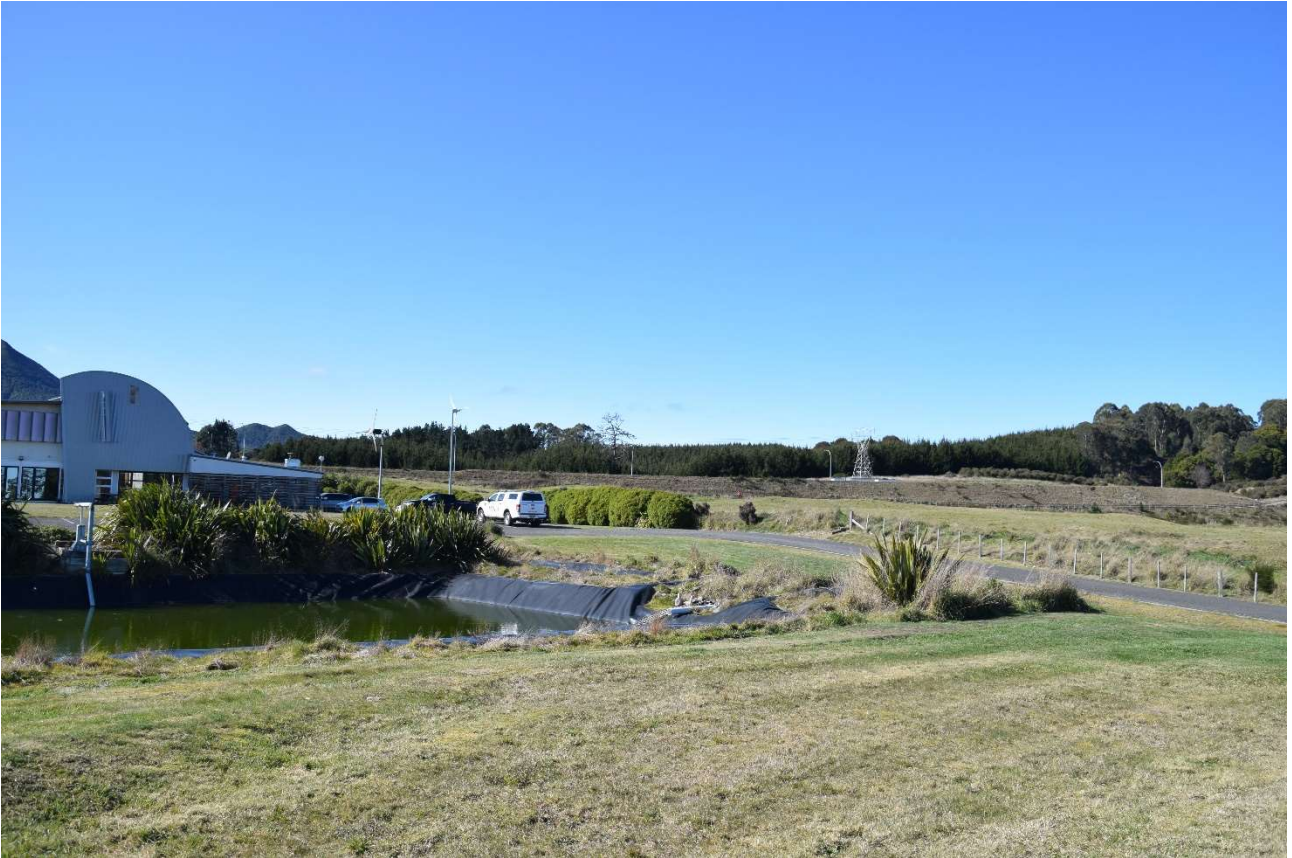
It should be noted that large water storage ponds such as the one located on site, if they rupture or leak for any reason, have potential to cause significant damage to downstream infrastructure. A recent example is the damage caused by the stormwater retention pond on Crown Road which ruptured in 2019 and caused considerable damage to adjacent infrastructure.

*Figure 7: View to the east, with water storage pond and existing building visible, ETA located in the distance*

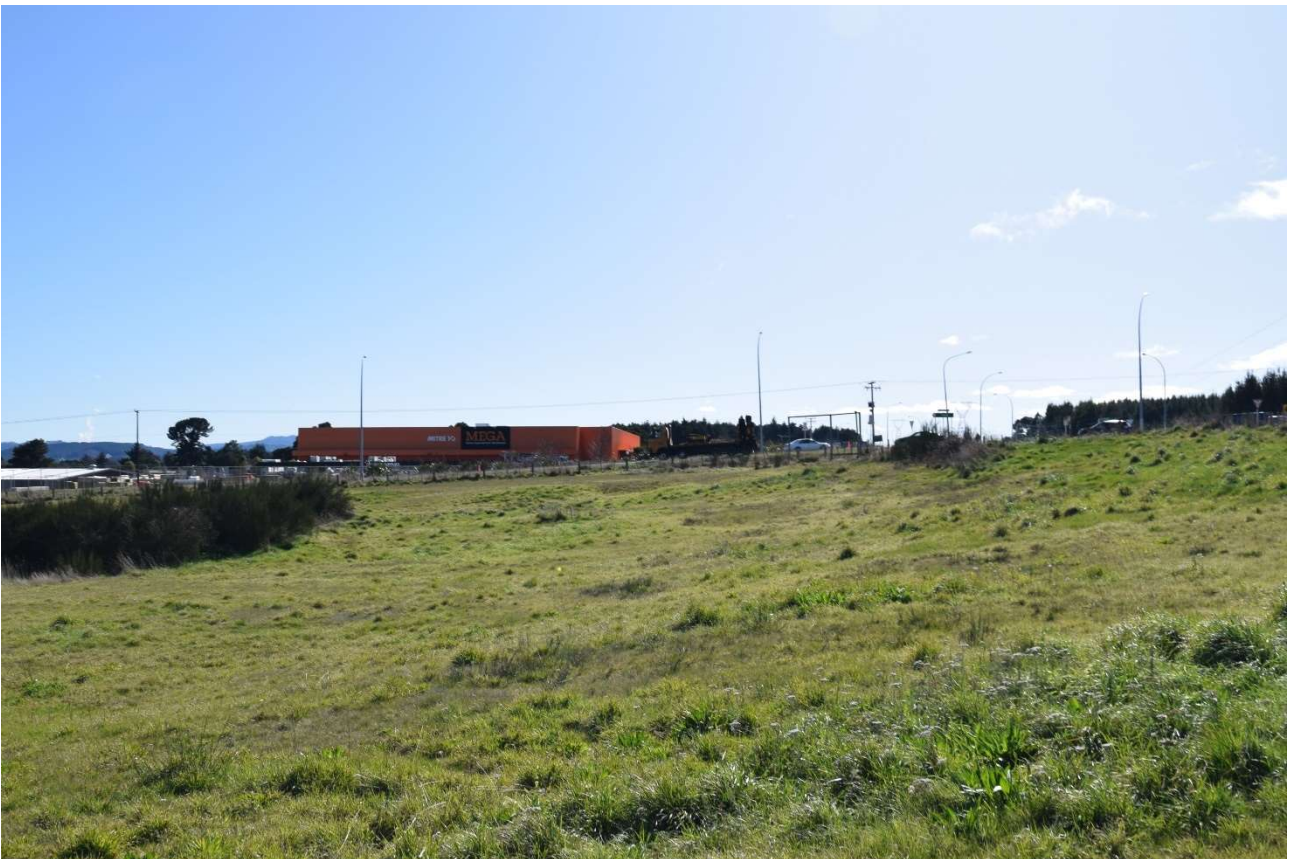
*Figure 8: View north towards Mitre 10 and existing industrial development showing general landform*
