Mark T Mitchell Ltd

Ref: T – 9036/1
19 October, 2006

**Re: Site Assessment and Supplementary Geotechnical Engineering Appraisal
Proposed Whareroa North Residential Subdivision
Hauhungaroa No. 6, Whareroa Road North, West Lake Taupo**

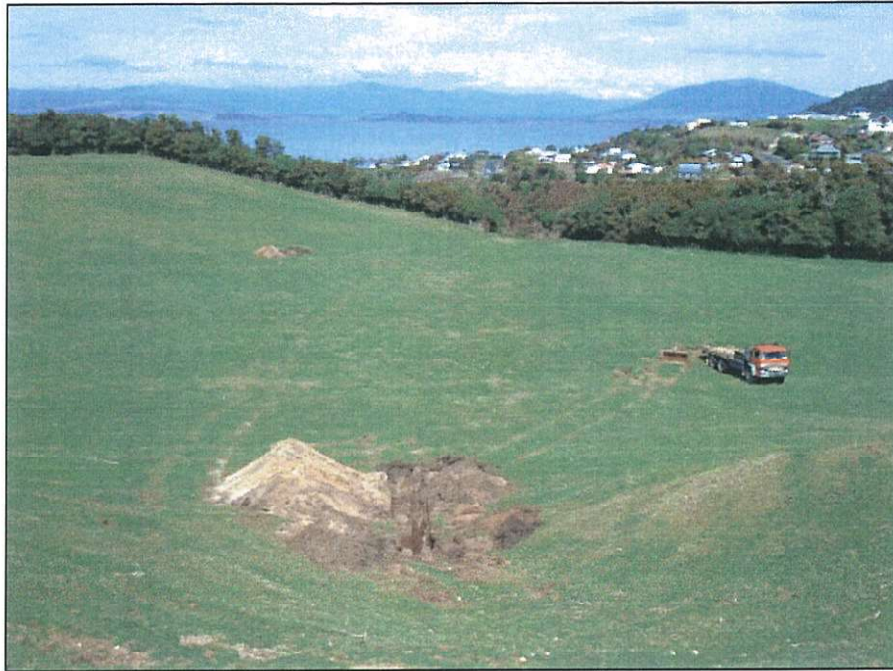
Fig. 1: View south towards the low-lying area with Lake Taupo in the distance. Test Pit No. 1 is in the foreground.

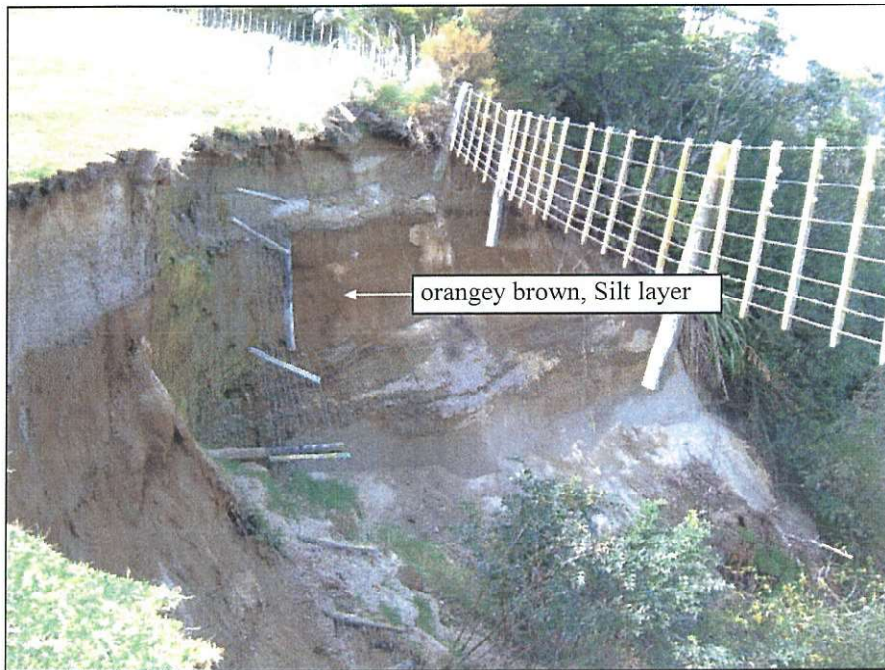
In the main, the site consists of a gently sloping terrace area. However, near the western edge of the subdivision, the land surface falls some 15 metres to a smaller, low-lying area. A steep slip-scarp is exposed along the south-western fenceline that drops to Whareroa Stream below. (ref. Fig. 2).

Fig. 2: Slip scarp along the south-western side of the subdivision displaying the distinct stratification of the volcanic soils.

Ground Profile AA displays the proposed stratification below the surface using information revealed by the test pits. The Silt layer can be seen to mantle the area and outcrops at the slip face some 1.5 metres below the surface as seen in Fig. 2.

The steep and high slip-scarp at the south-western fenceline that runs down to the stream below will required remedial action to be taken as soon as possible as it appears that this erosion failure-feature is increasing in size.
