Project Number: 2-37928.00

# Wairakei Subdivision

## Preliminary Geotechnical Assessment Report

21 February 2022

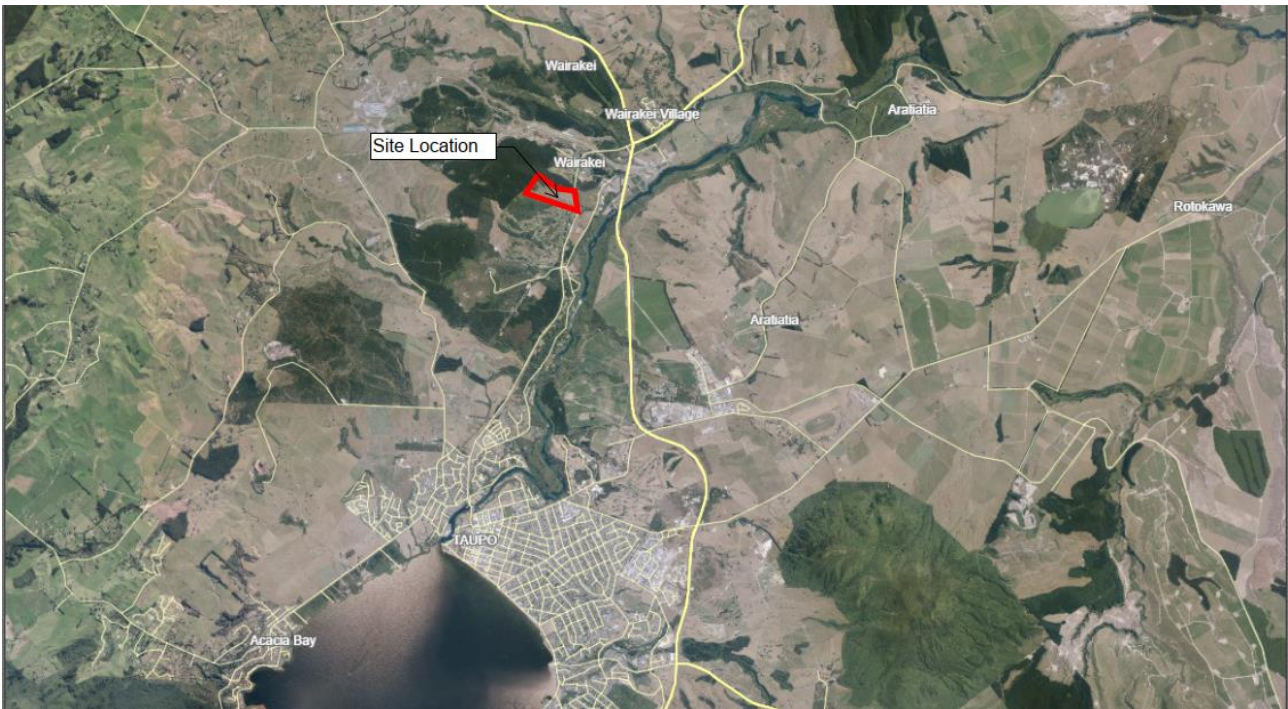
Figure 3-1: Site location

an elevation of 480m RL along the western boundary and 400m RL along the eastern boundary. A gully feature runs from west to east along the southern side of the site with 10m to 20m high slopes at gradients from 1H:1V to 1.5H:1V. A slope along the western boundary rises 20m at a gradient of 5H:1V to 6H:1V. A site location plan is shown on Figure 3-1.

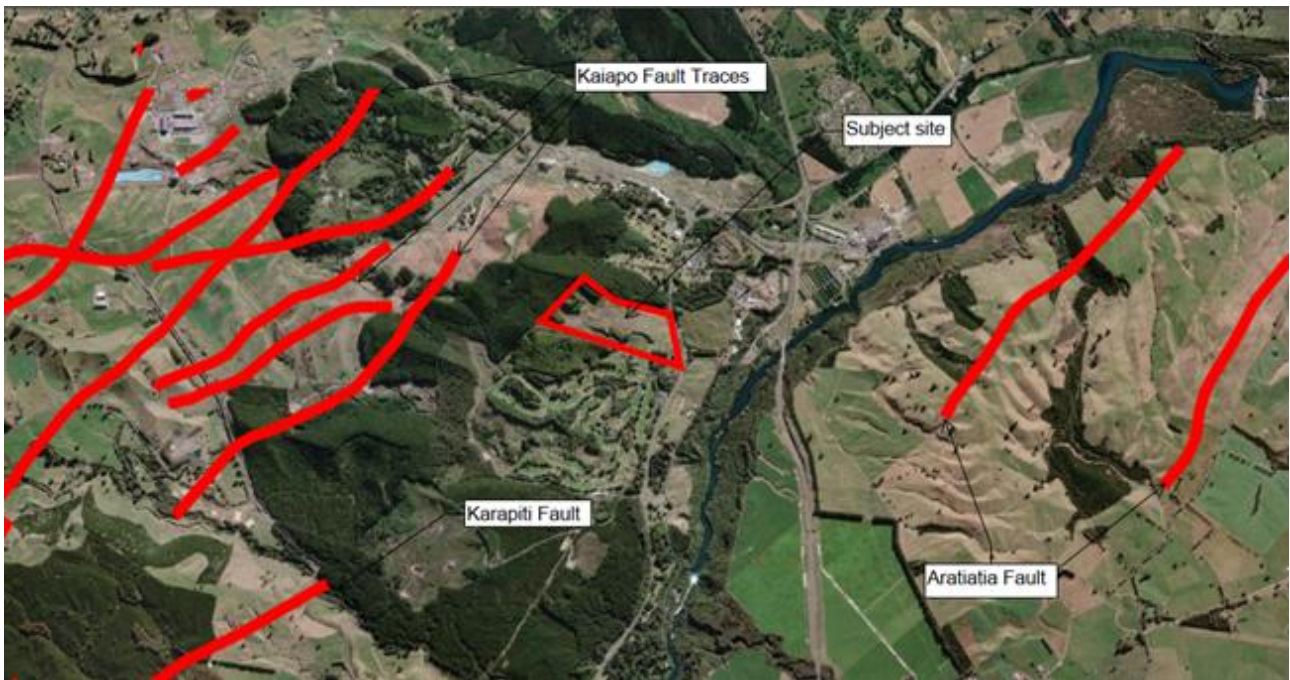
Figure 4-3: Fault Locations

According to the GNS Active Fault Database, there are three identified active faults within 5km of the site, the Karapiti Fault, multiple traces of the Kaiapo Fault, and two traces of the Aratiatai fault. The fault locations are presented in Figure 4-3.

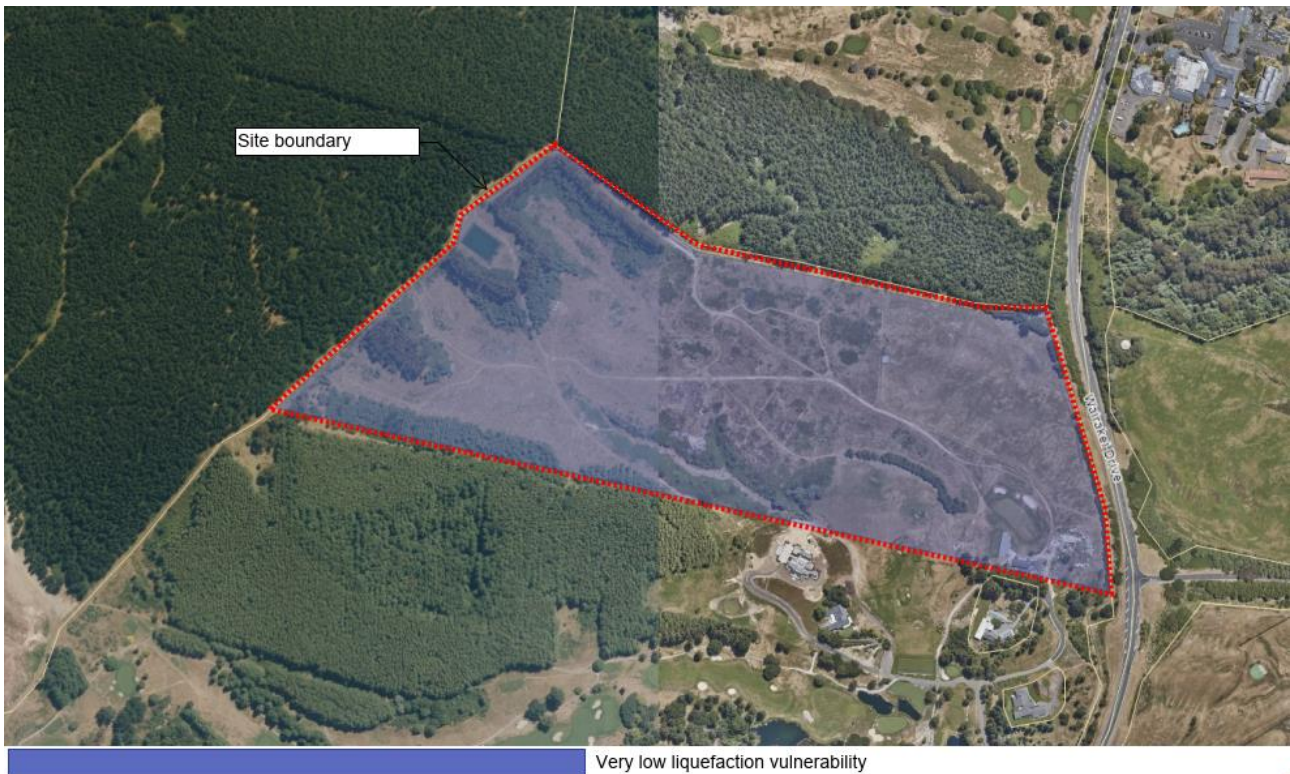
Figure 6-1: Preliminary liquefaction vulnerability map

We have completed calculations of liquefaction triggering for the 1/25 year, and 1/500 year earthquakes along with a parametric assessment of groundwater at 10m, 15m, and 20m depth. The results indicate a negligible risk of liquefaction triggering and associated land damage. A detailed summary of the calculations and results is presented in the Appendix.

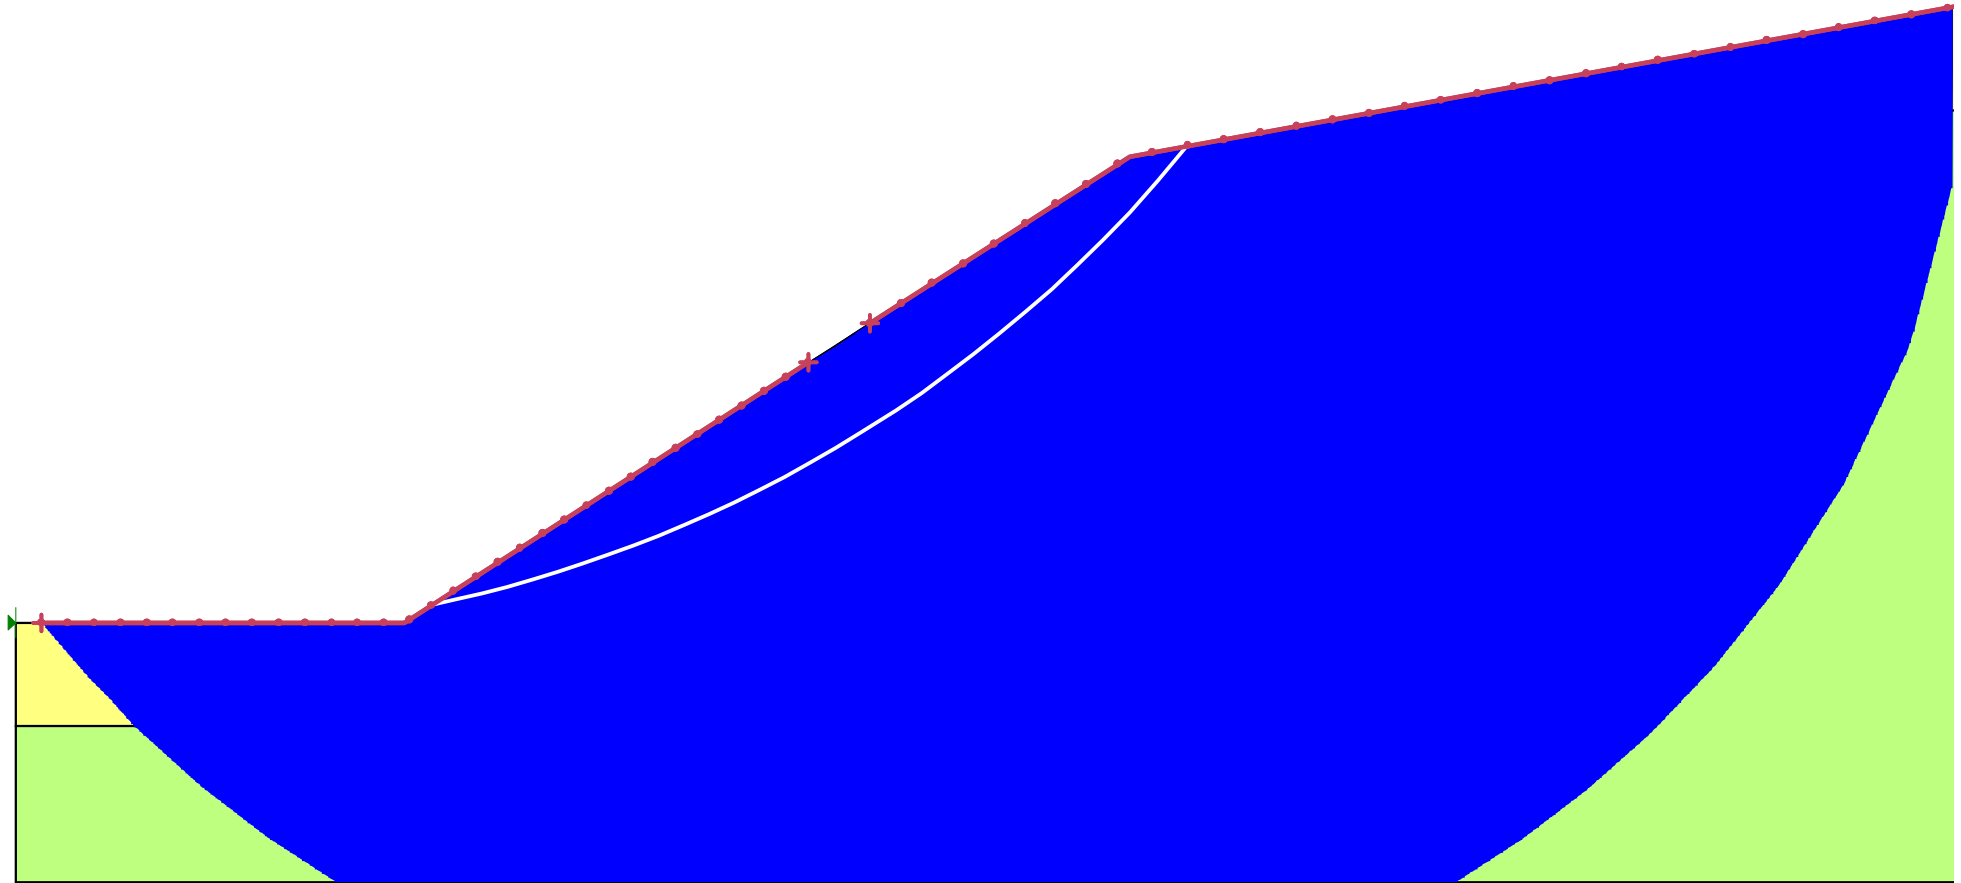
Color	Name	Slope Stability Material Model	Unit Weight (kN/m³)	Effective Cohesion (kPa)	Effective Friction Angle (°)	$R_u$ <sup>1.489</sup>
Light Green	Lower Pumice	Mohr-Coulomb	14	5	40	0
Yellow	Upper Pumice	Mohr-Coulomb	14	5	35	0

Project:	Wairakei Golf Course Residential			Method	Morgenstern-Price
Analysis:	Static			Scale	1:292
Modelled By:	Preston, Johnathon	Checked By:	Name	PGA	0g
		Analysis Type:	SLOPE/W	Date:	14/02/2022
				FOS	1.489

Calculated Factors of Safety are presented in Table 6-1. A recommended setback distance from the slope crest was determined by finding the distance behind the crest where the minimum factor of safety for all cases increases to at least 1.5. On this basis we have calculated a recommended setback distance of 10m from the slope crest.

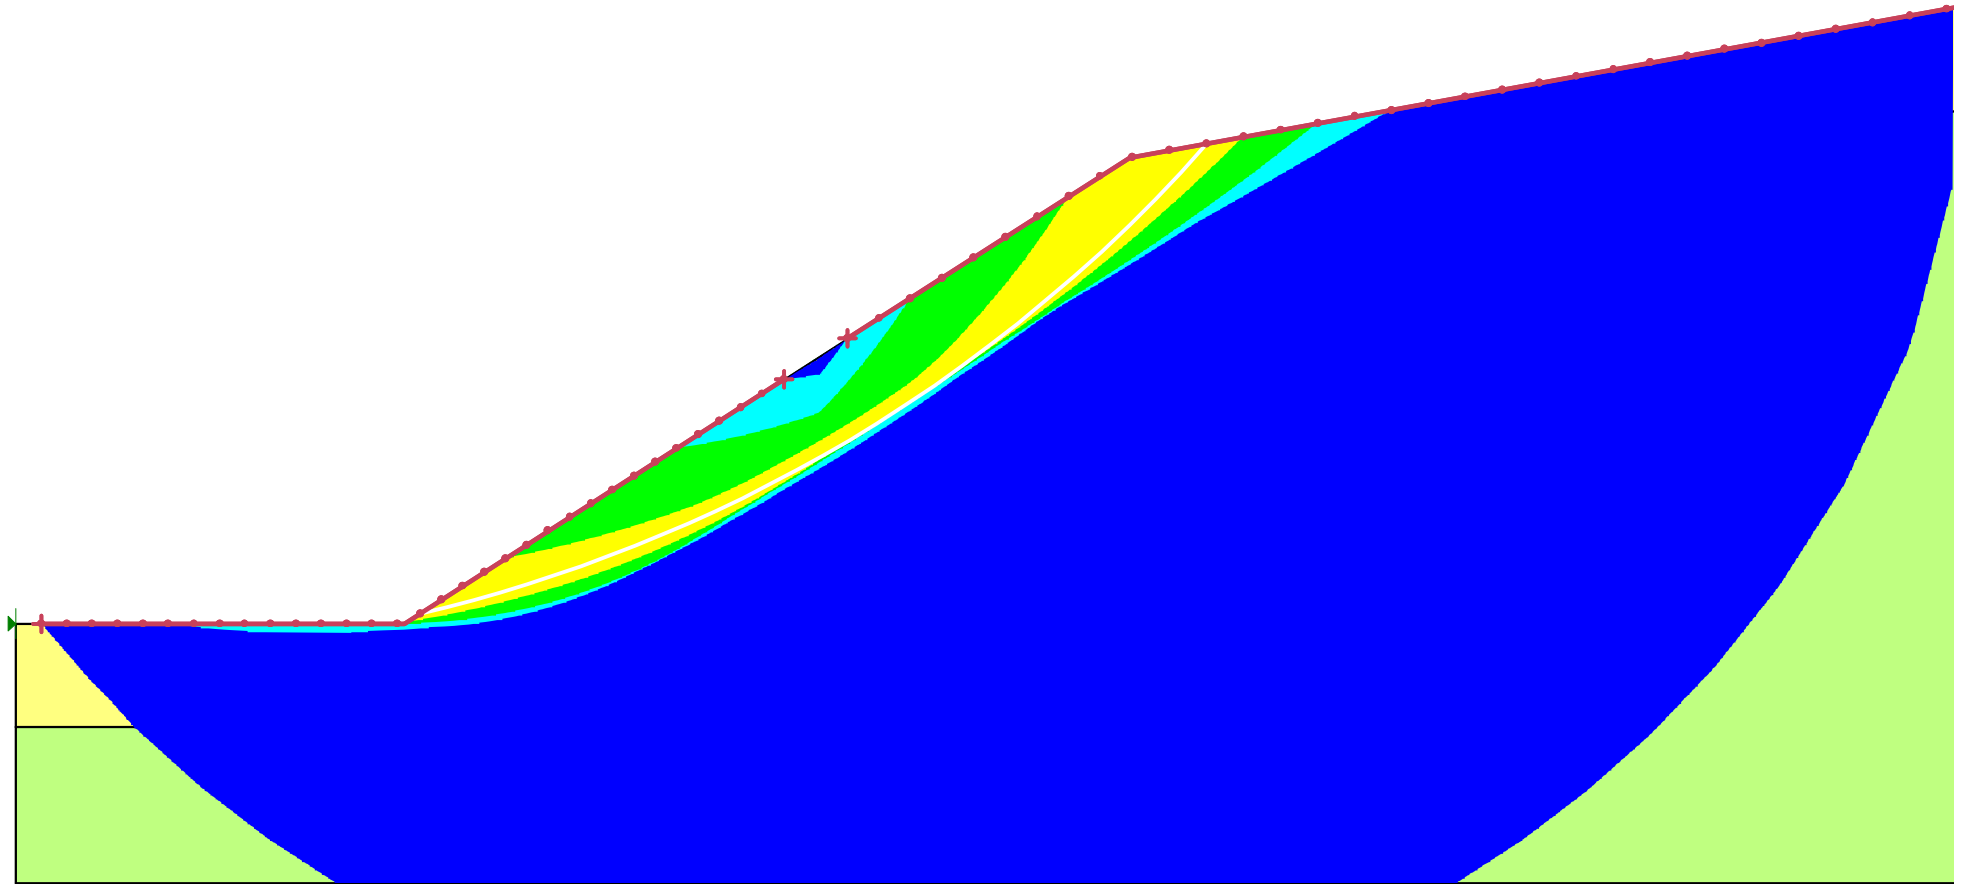
Color	Name	Slope Stability Material Model	Unit Weight (kN/m³)	Effective Cohesion (kPa)	Effective Friction Angle (°)	$R_u$ <sup>1.168</sup>
Light Green	Lower Pumice	Mohr-Coulomb	14	5	40	0
Yellow	Upper Pumice	Mohr-Coulomb	14	5	35	0.2

Project:	Wairakei Golf Course Residential			Method	Morgenstern-Price
Analysis:	Elevated Groundwater			Scale	1:292
Modelled By:	Preston, Johnathon	Checked By:	Name	PGA	0g
		Analysis Type:	SLOPE/W	Date:	14/02/2022
				FOS	1.168

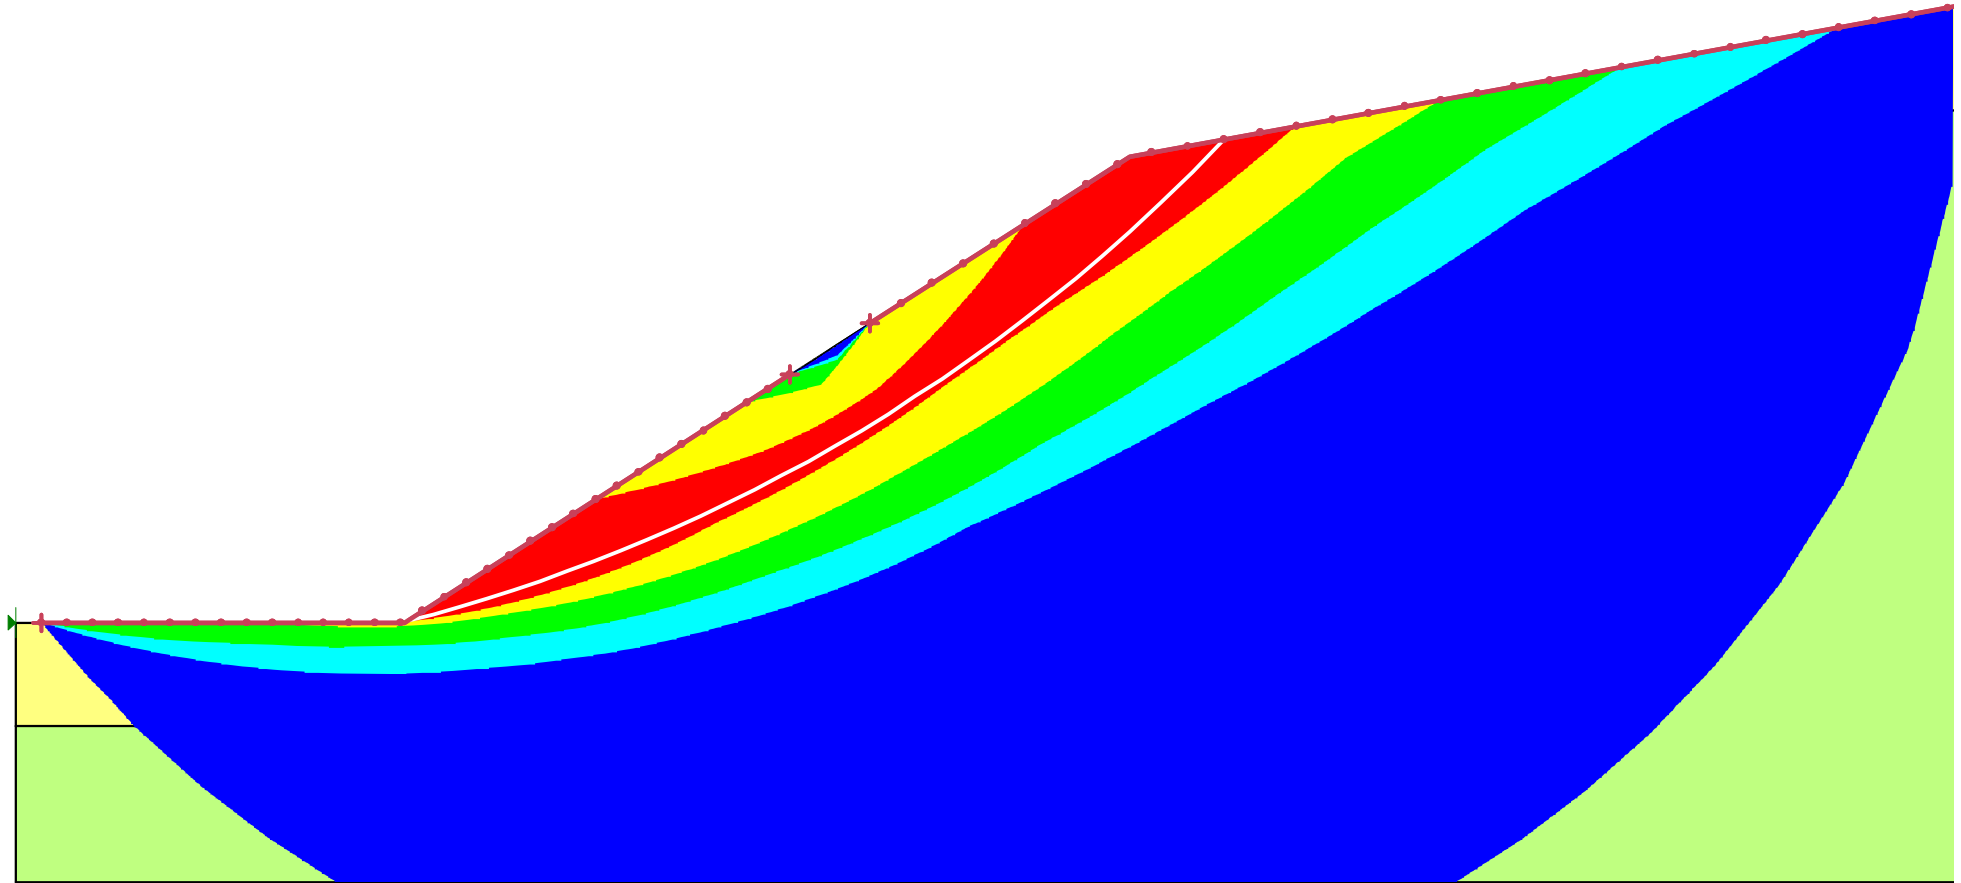
Color	Name	Slope Stability Material Model	Unit Weight (kN/m³)	Effective Cohesion (kPa)	Effective Friction Angle (°)	$R_u^{1.038}$
Light Green	Lower Pumice	Mohr-Coulomb	14	5	40	0
Yellow	Upper Pumice	Mohr-Coulomb	14	5	35	0

Project:	Wairakei Golf Course Residential				Method	Morgenstern-Price	
Analysis:	Seismic				Scale	1:292	
Modelled By:	Preston, Johnathon	Checked By:	Name	Analysis Type:	SLOPE/W	PGA	0.195g
				Date:	14/02/2022	FOS	1.038
