# PRELIMINARY SITE INVESTIGATION

## WAIRAKEI INTERNATIONAL GOLF COURSE WAIRAKEI

PROJECT NO. EAM2202-01

PREPARED FOR  
TW GROUP

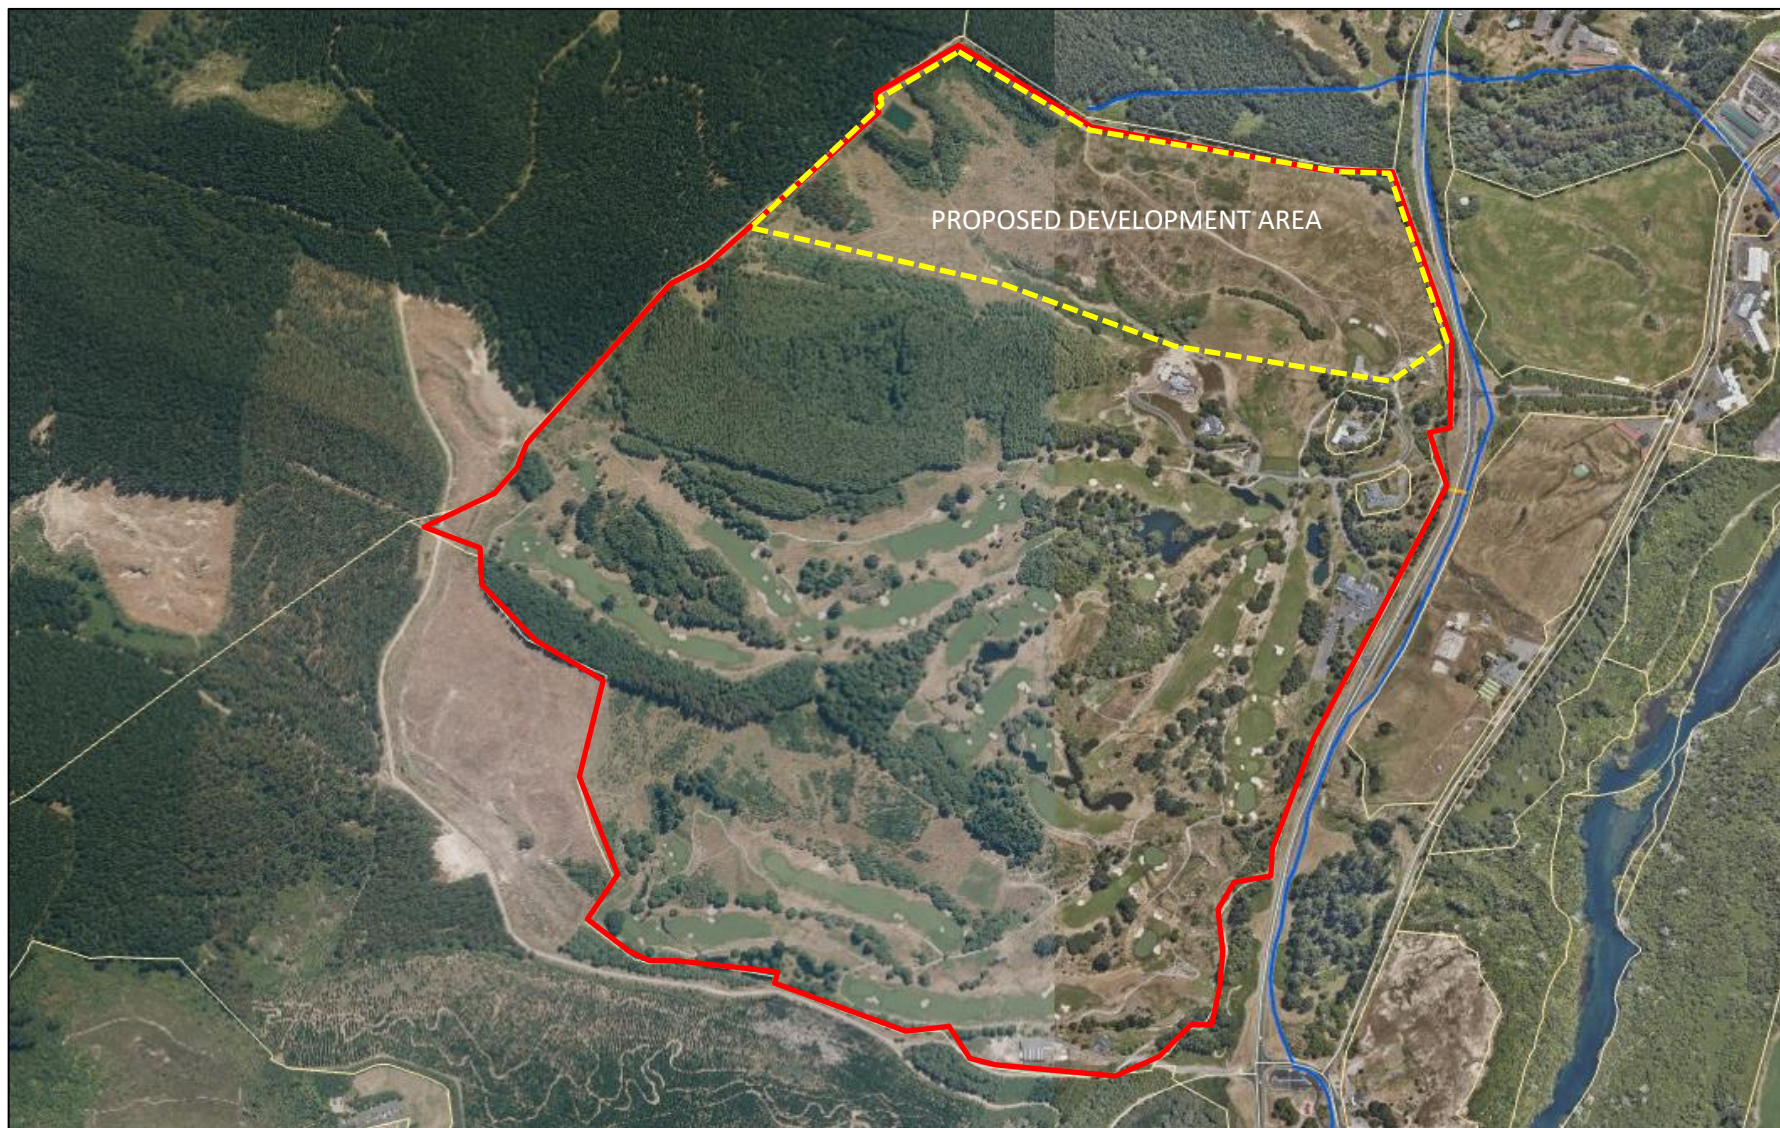
FIGURE 1. SITE LAYOUT AND BOUNDARY

The Site is located at 1/527 Wairakei Drive, Wairakei. The legal description for the property is Lot 1 DP 426900 and occupies a total area of 145.57 ha.

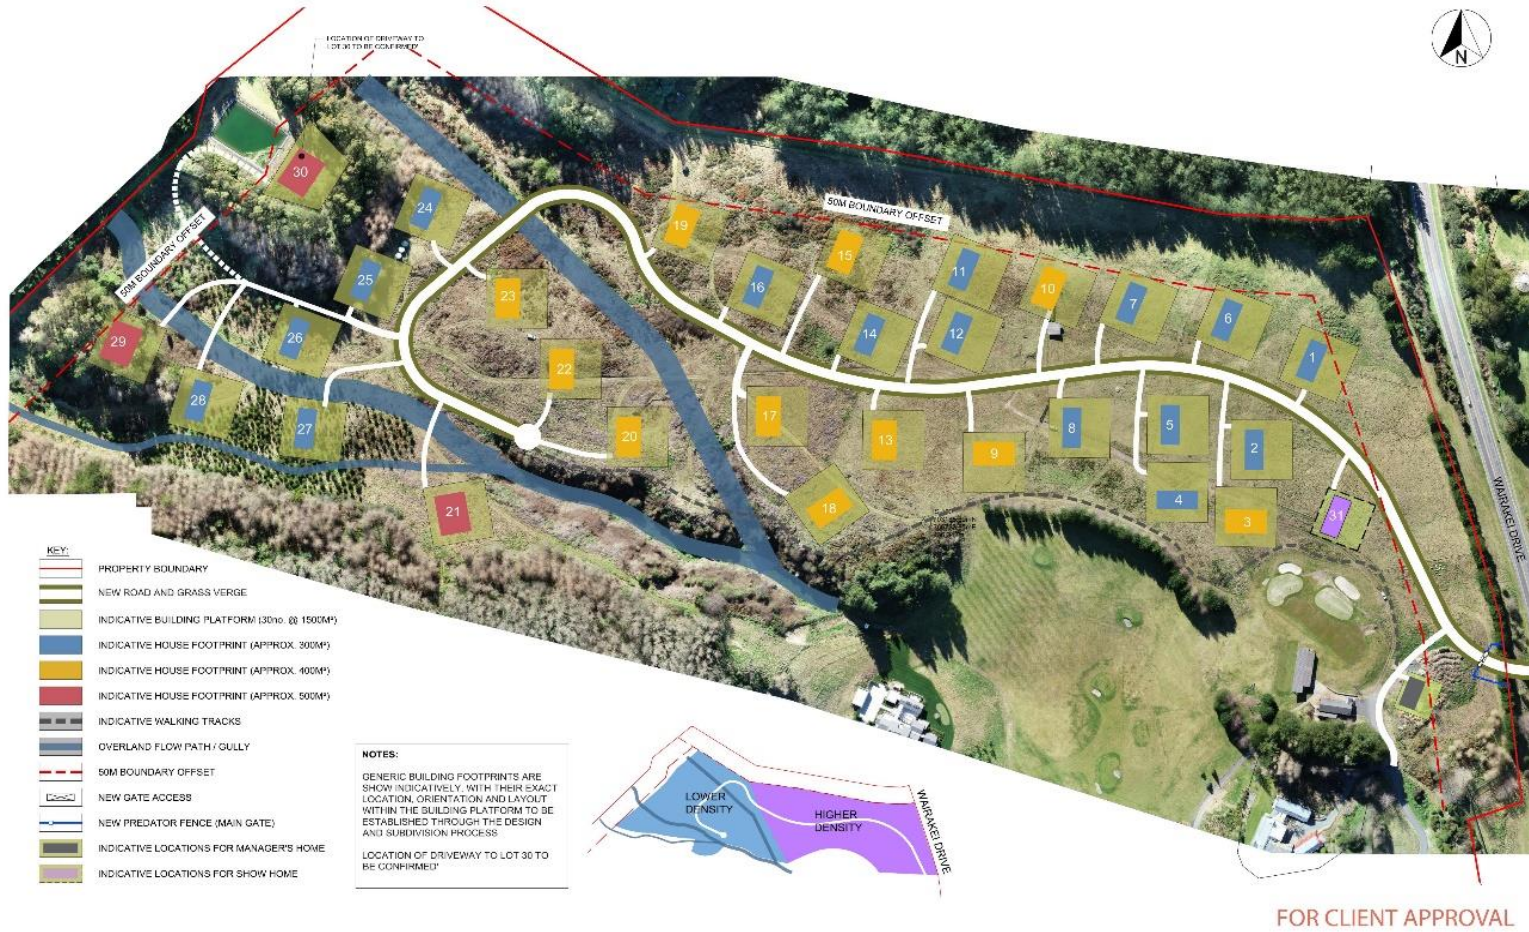
FIGURE 2. SITE CONCEPT PLAN

Wairakei International Golf Course | Concept Plan: Preferred Option (Mixed Density Layout)

Figures 1 and 2 of Appendix A illustrate the property location and the site concept development plan.

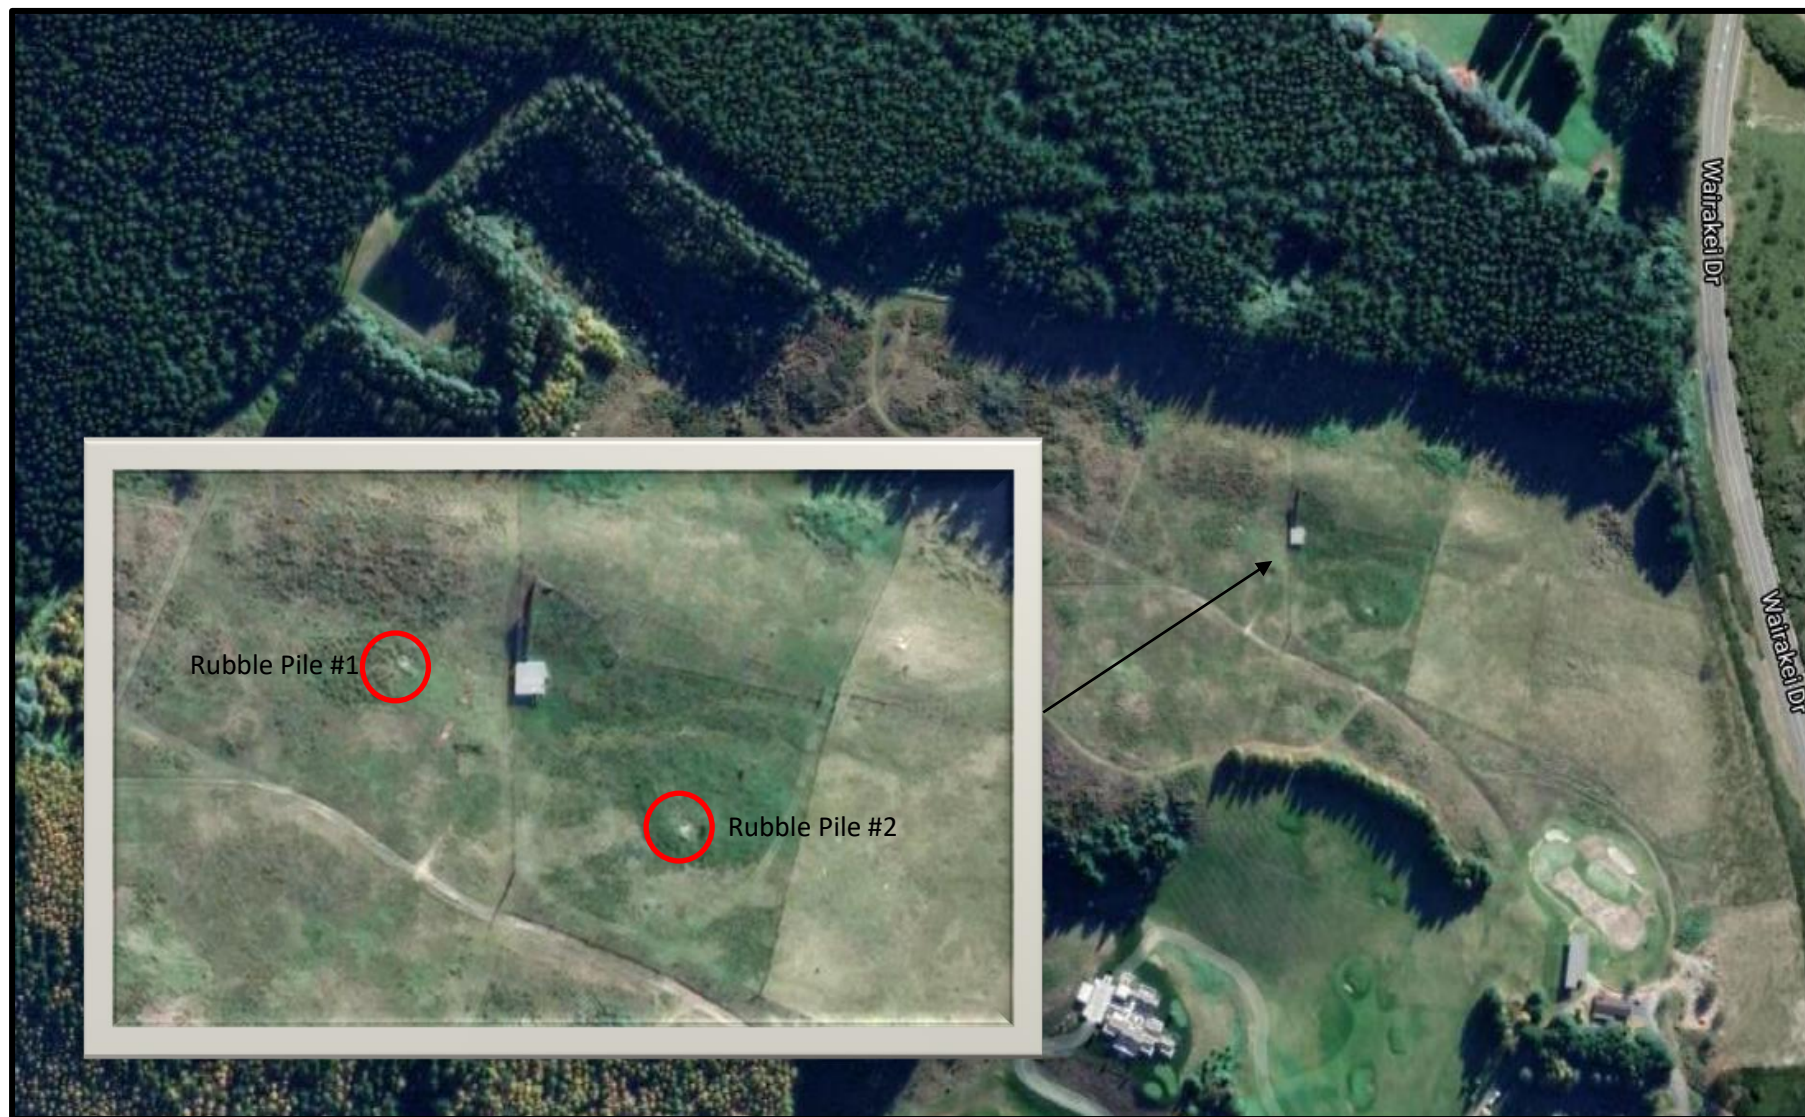
FIGURE 3. SOIL SAMPLE LOCATIONS

Four soil samples were collected from two locations at the site. Samples were collected from these two locations due to the presence of large slabs of partially buried concrete and rubble in two separate areas. Not knowing the source of the rubble, samples were collected for preliminary analysis. Soils were collected from 0-150mm and 150-300mm at each location.

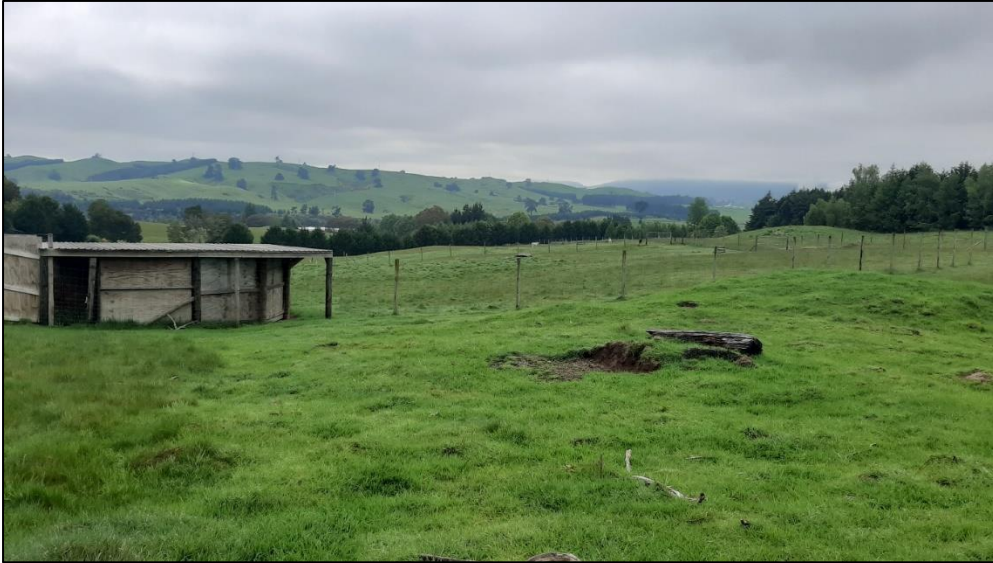
The eastern third of the site is currently utilised for agriculture, with the land fenced into paddocks with tall deer fencing. A mob of deer and a herd of goats currently occupy these paddocks. A deer shed constructed of timber, ply, wire, and corrugated iron is located within this area. A reticulated water system is visible, providing stock water to small troughs. In this area are two large piles of rubble and concrete slabs. The soil is mounded and uneven around these areas suggesting potential burial, or movement of soil. No waste material was observed other than concrete rubble and slabs.

PHOTO 1. DEER SHED AND PASTURES

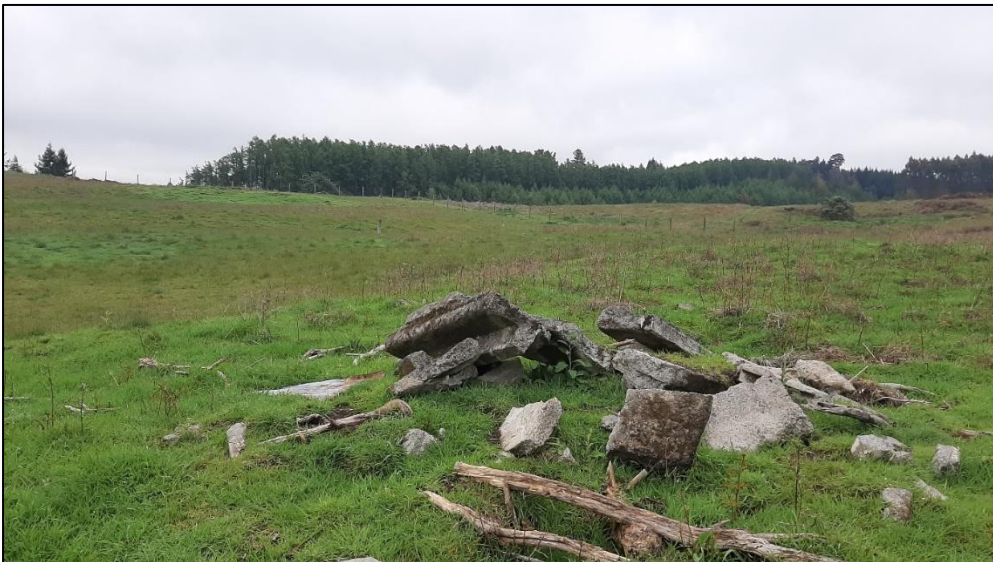
Presence of the rubble and concrete may indicate a structure or building formerly present at the location. It could also be relocated material from another location on the site. To establish whether potential contamination may result from this material, metals and OCP were analysed as a precautionary measure.

PHOTO 2. RUBBLE REMAINS FROM FORMER BUILDING STRUCTURES

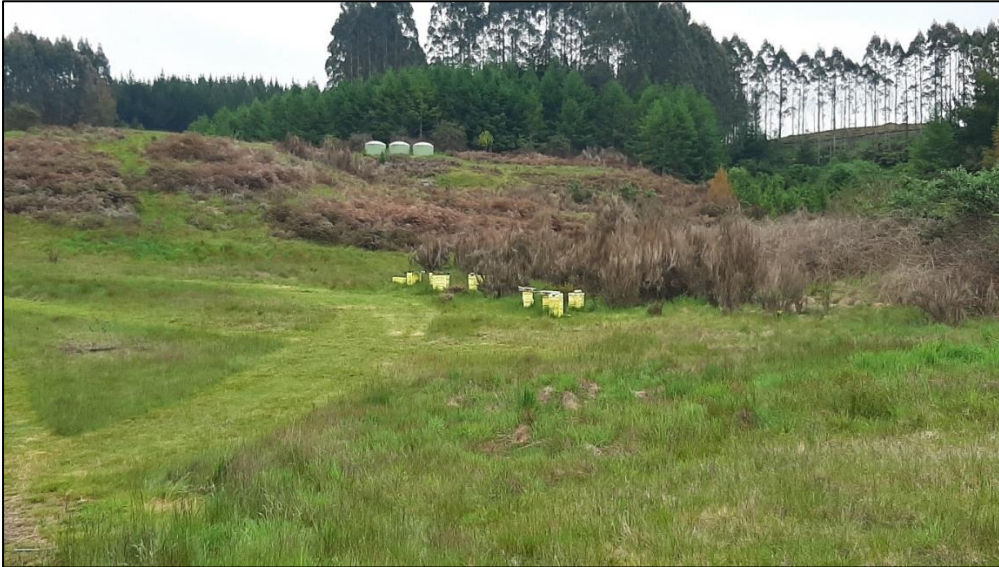
To the west of this area, the site becomes overgrown with bracken, blackberry, grass, and weeds, before migrating into established vegetation and large trees. A cluster of beehives are present. A group of three water tanks, and another individual tank are observed higher up on the site, likely to gravity feed down to the areas of lower topography.

PHOTO 4. WATER TANKS, BEEHIVES AND VEGETATION

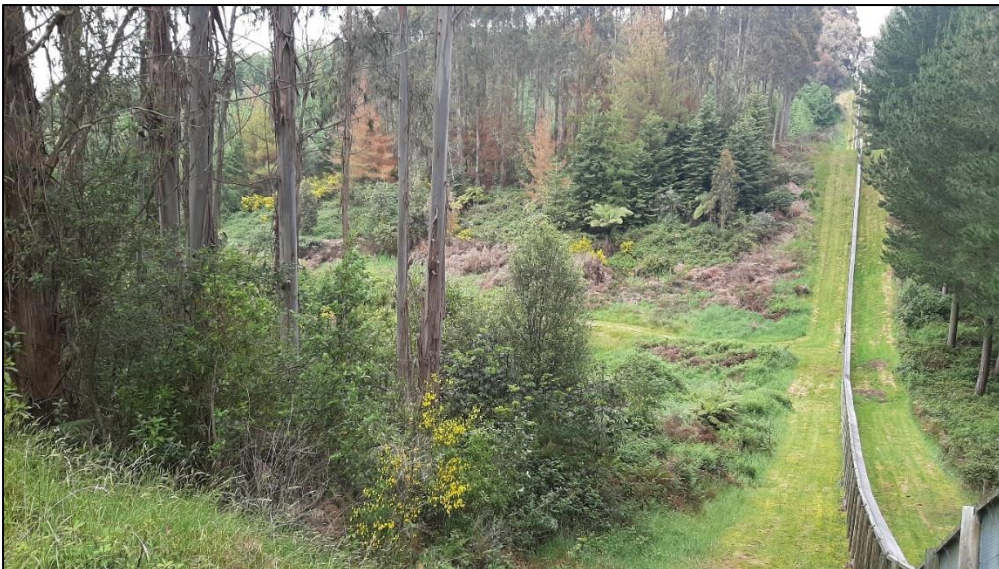
Aside from the deer shed, there are no buildings or features on the site aside from stock fencing. The outer boundary on the north, east and western sides are predator free-fence line.

PHOTO 5. PREDATOR FREE FENCELINE BOUNDARY

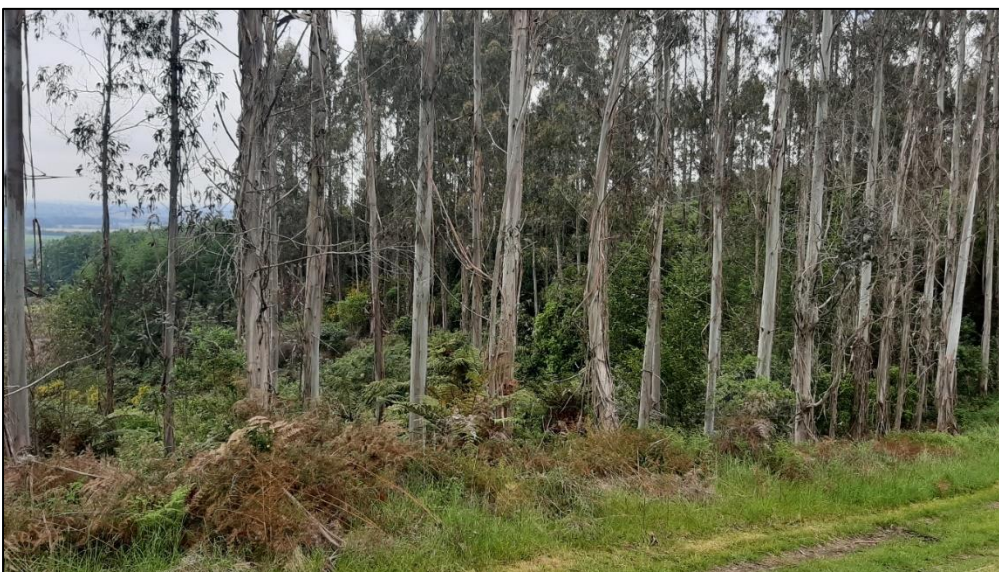
The western most extent of the site is thickly planted with a mixture of established eucalyptus and conifer stands. Native vegetation fills the understory. A large water storage pond is located on the western boundary, which is to be outside of the proposed site plans. Cleared tracks extend throughout the site for vehicle access.

PHOTO 6. EUCALYPTUS PLANTATION

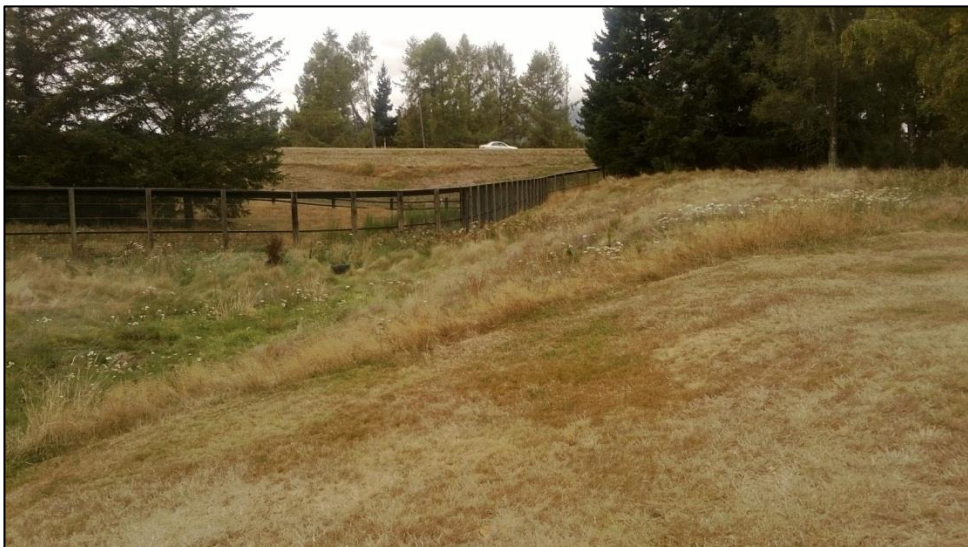
FIGURE 5: VIEW OF STORMWATER DRAINAGE CHANNEL/SWALE ON EASTERN BOUNDARY THE FIRST TEE AT WAIRAKEI INTERNATIONAL GOLF COURSE
