ECOLOGICAL ASSESSMENT OF
THE TAUPO COMMERCIAL AND
INDUSTRIAL STRUCTURE PLAN

NOVEMBER 2008

Report No. 2019

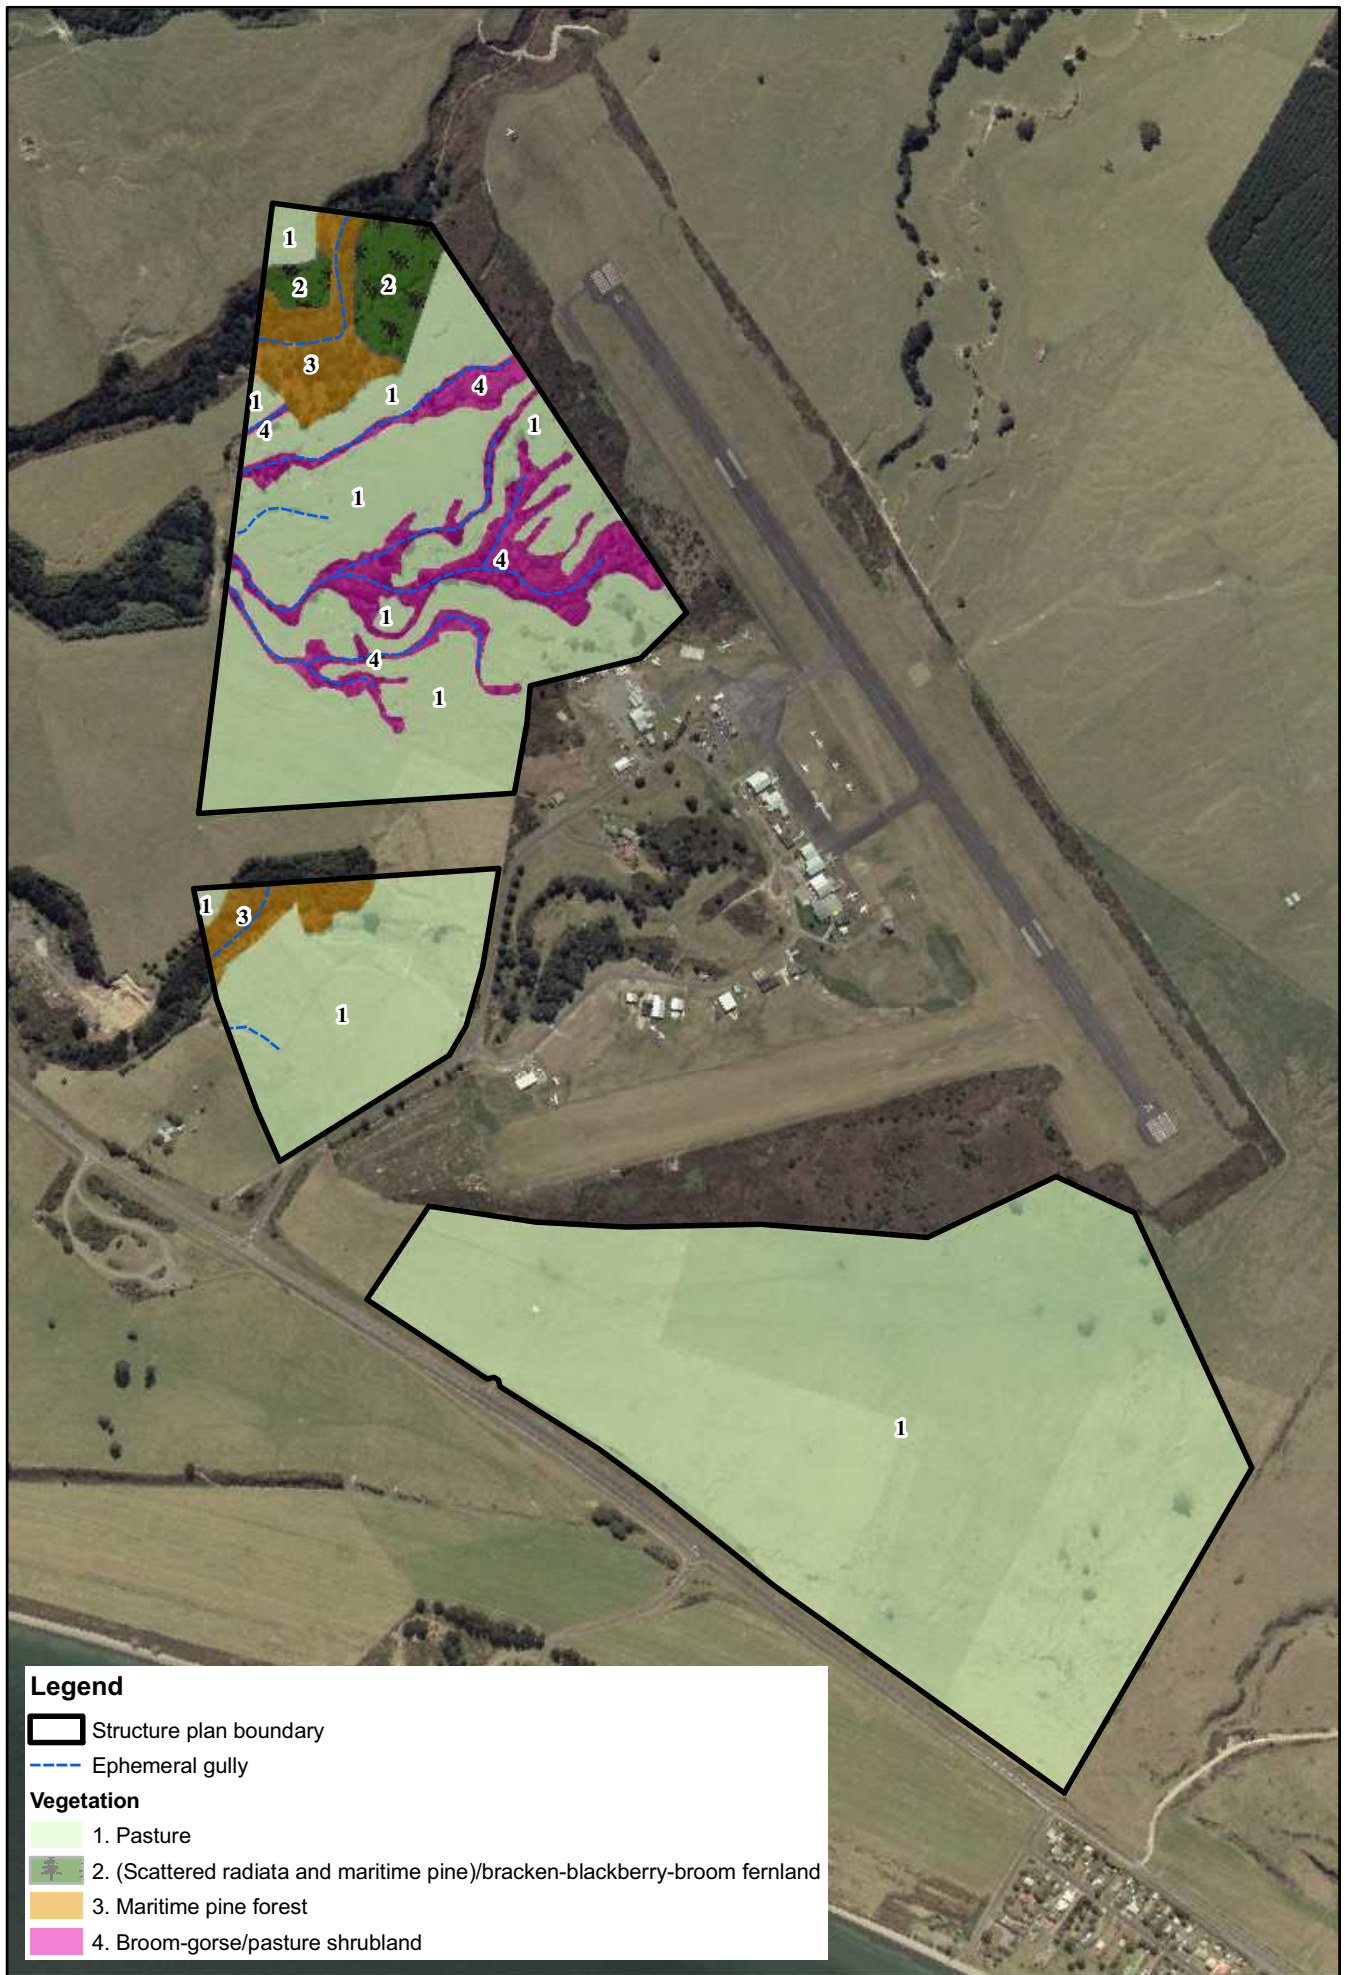
Figure 8. Vegetation/habitat types and land use, Taupo Airport Block

4. Eucalyptus plantation (c.1.88 ha)
5. Radiata pine-mixed deciduous plantation (c.0.4 ha)
6. Roads (c.1.5 ha)

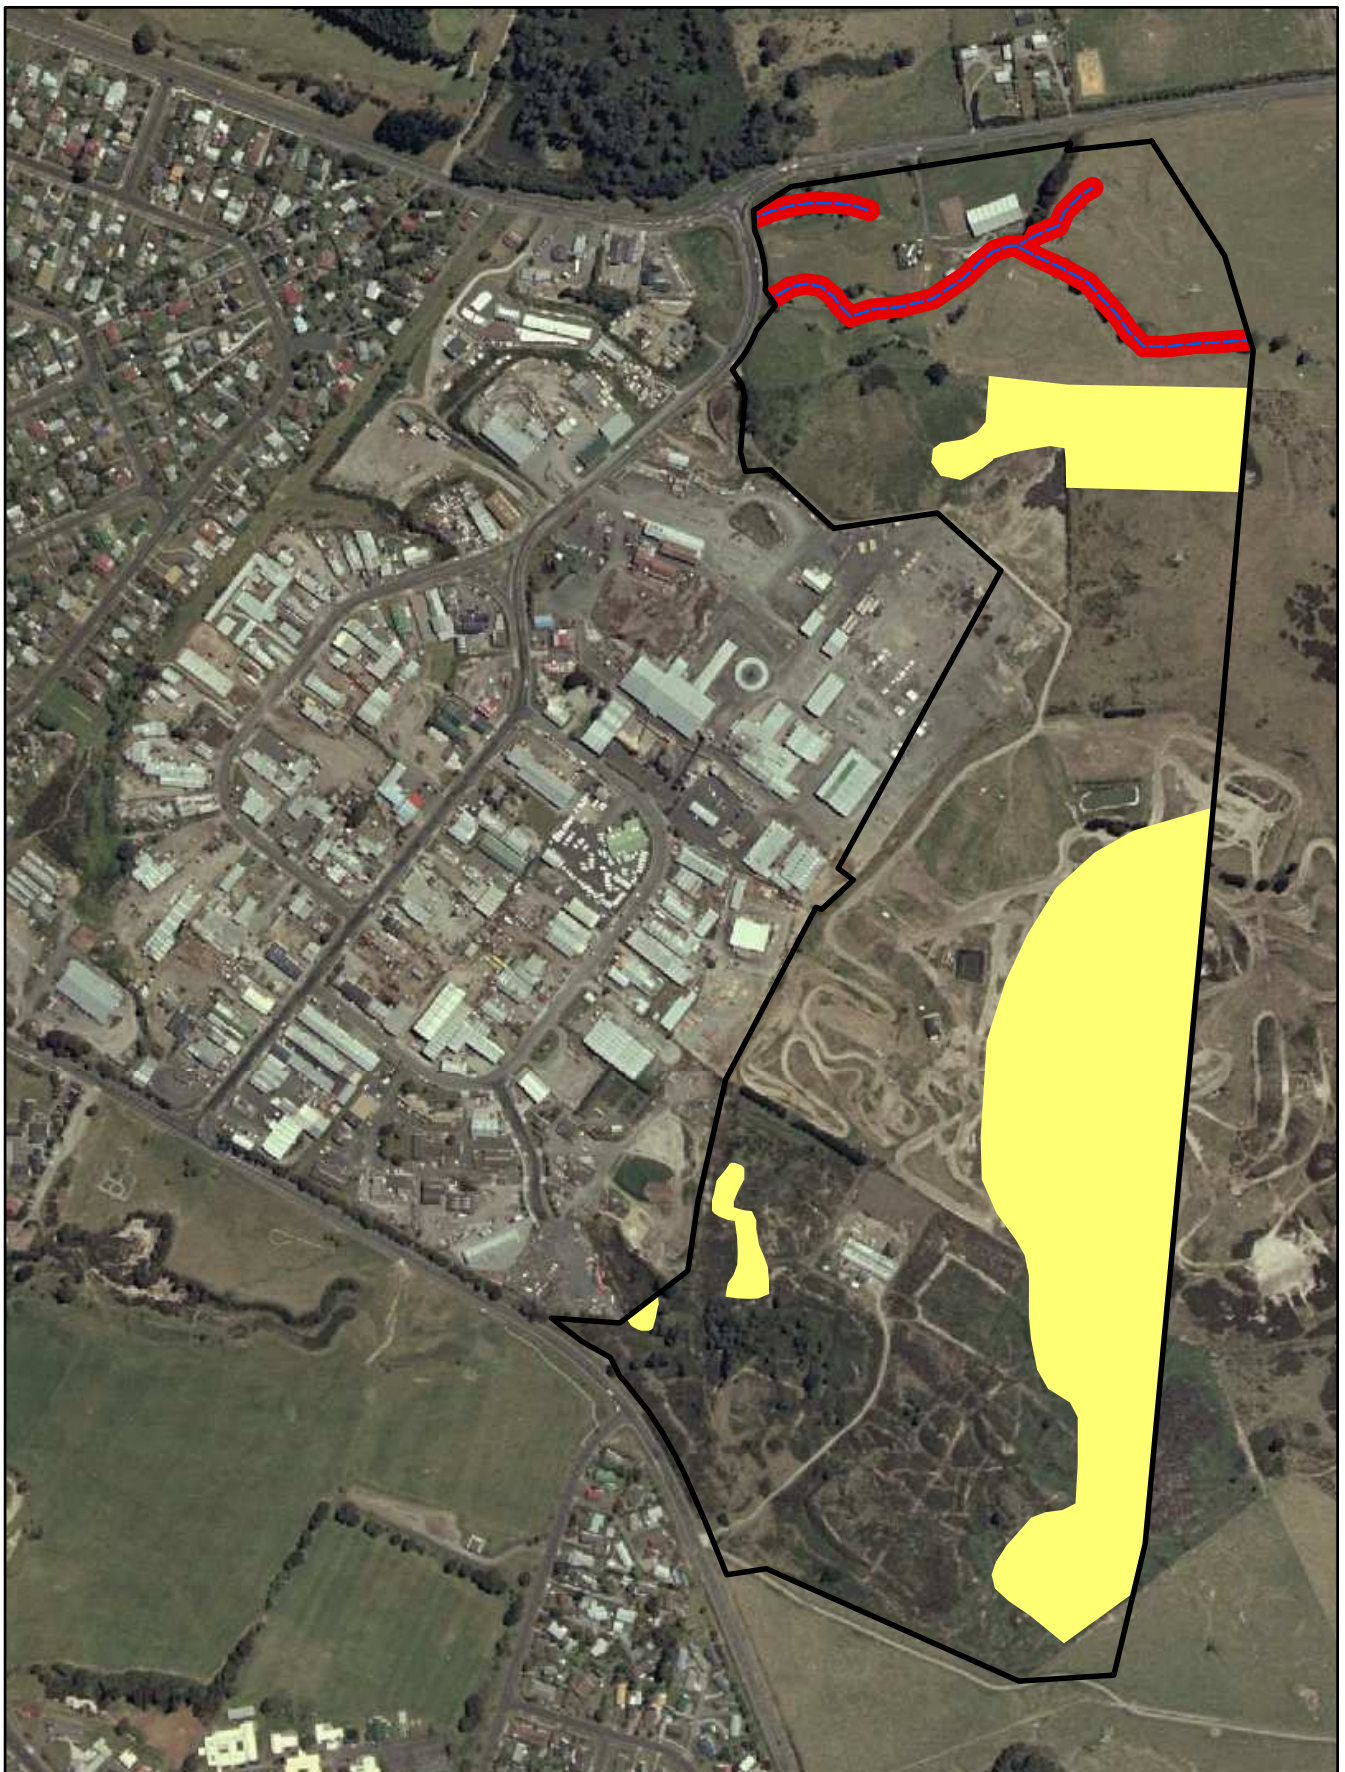
- Structure plan boundary
- Ephemeral gully
- Geothermal vegetation and associated buffer on margins – no development recommended
- Deeply-incised gully. No development recommended

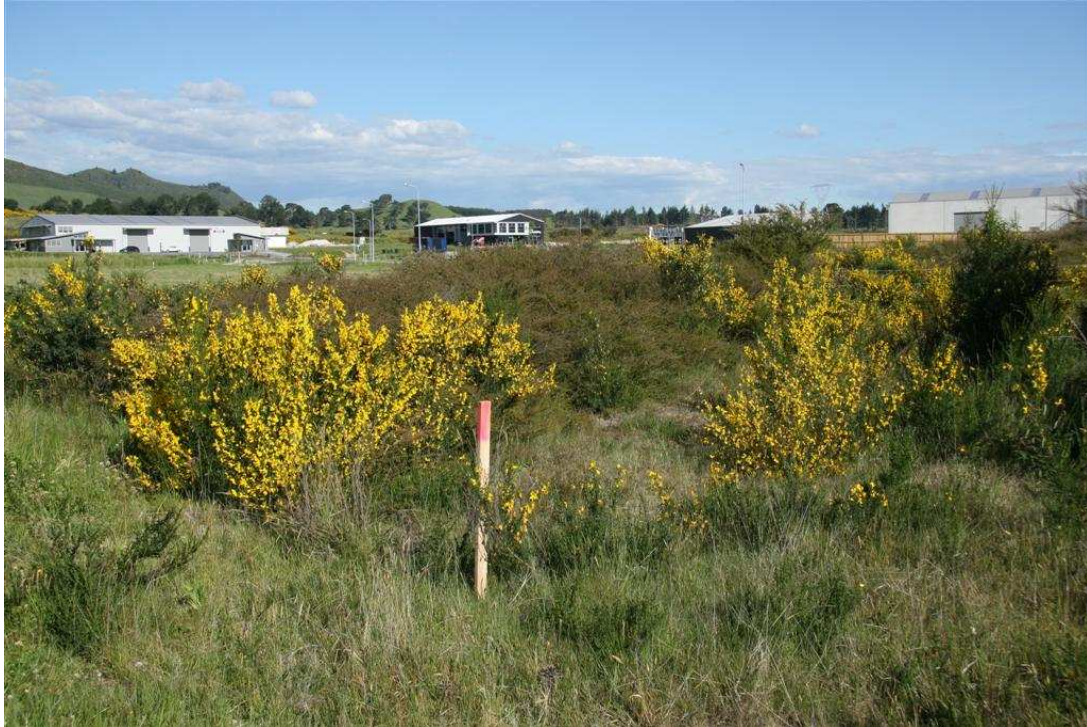
Plate 1: Prostrate kanuka scrub and wilding pine tree near Ashwood Park.

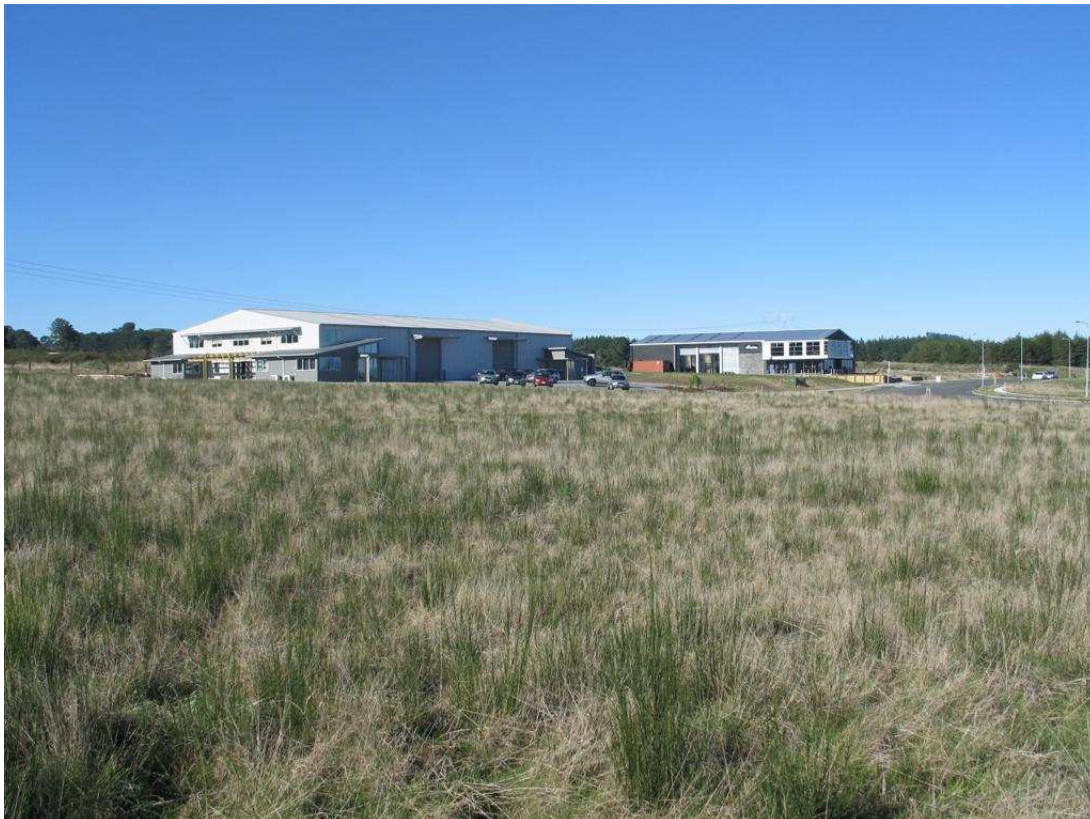
Plate 2: Ashwood Park subdivision. Prostrate kanuka scrub sites were destroyed at this site when this development was undertaken.

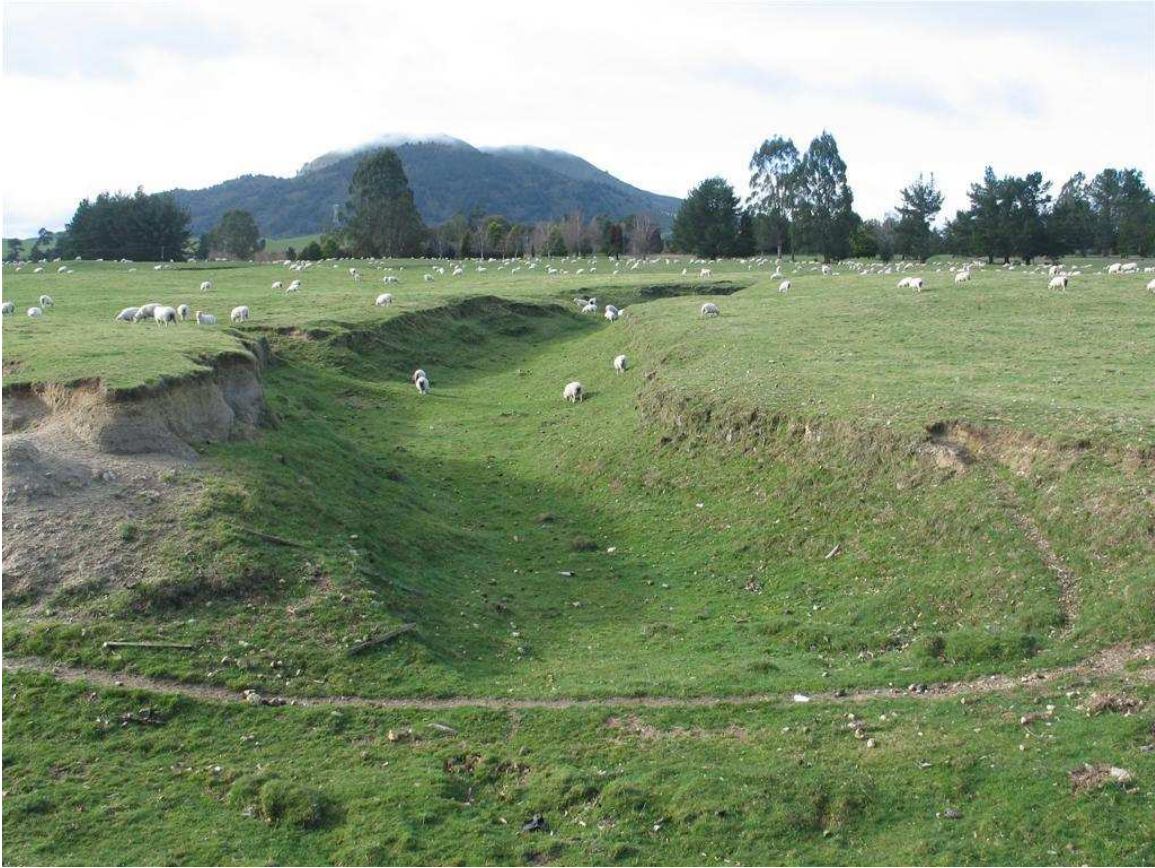
Plate 3: Pasture and shallow ephemeral gully near Centennial Drive.

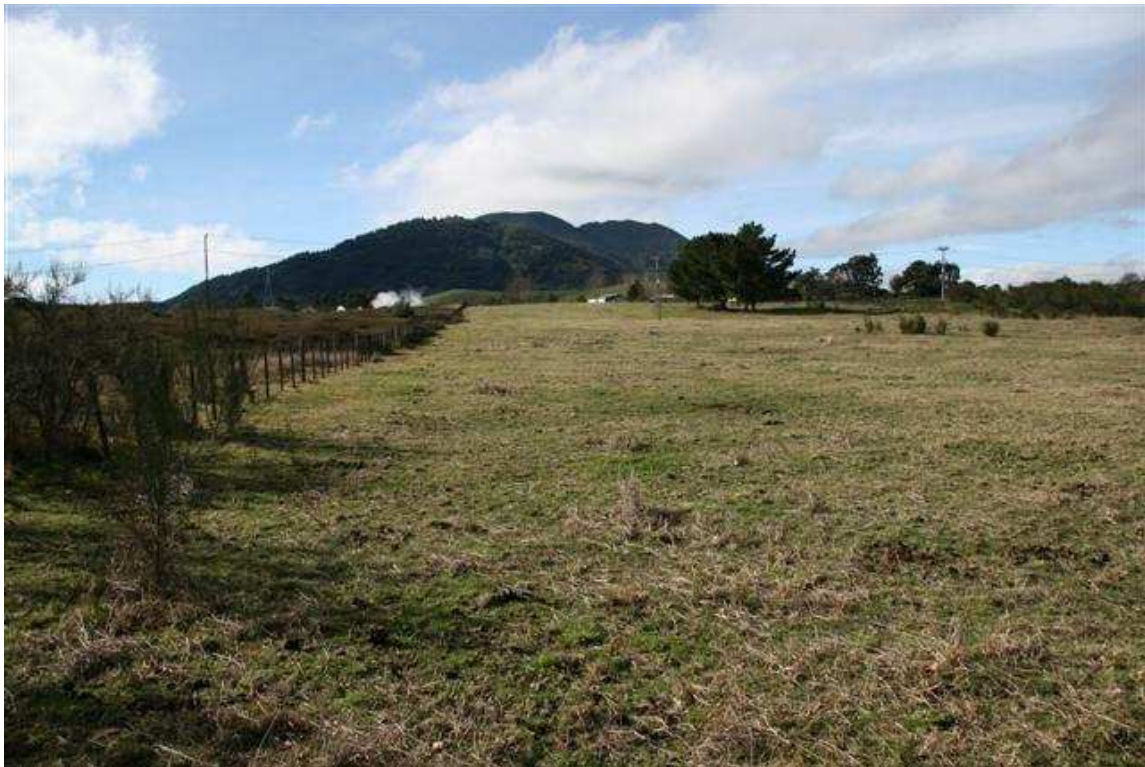
Plate 4: Pasture, currently grazed by horses on the northern side of Broadlands Road, near boundary of the geothermal habitat of Broadlands Road Scenic Reserve. Prostrate kanuka scrub is present to the left of fence.

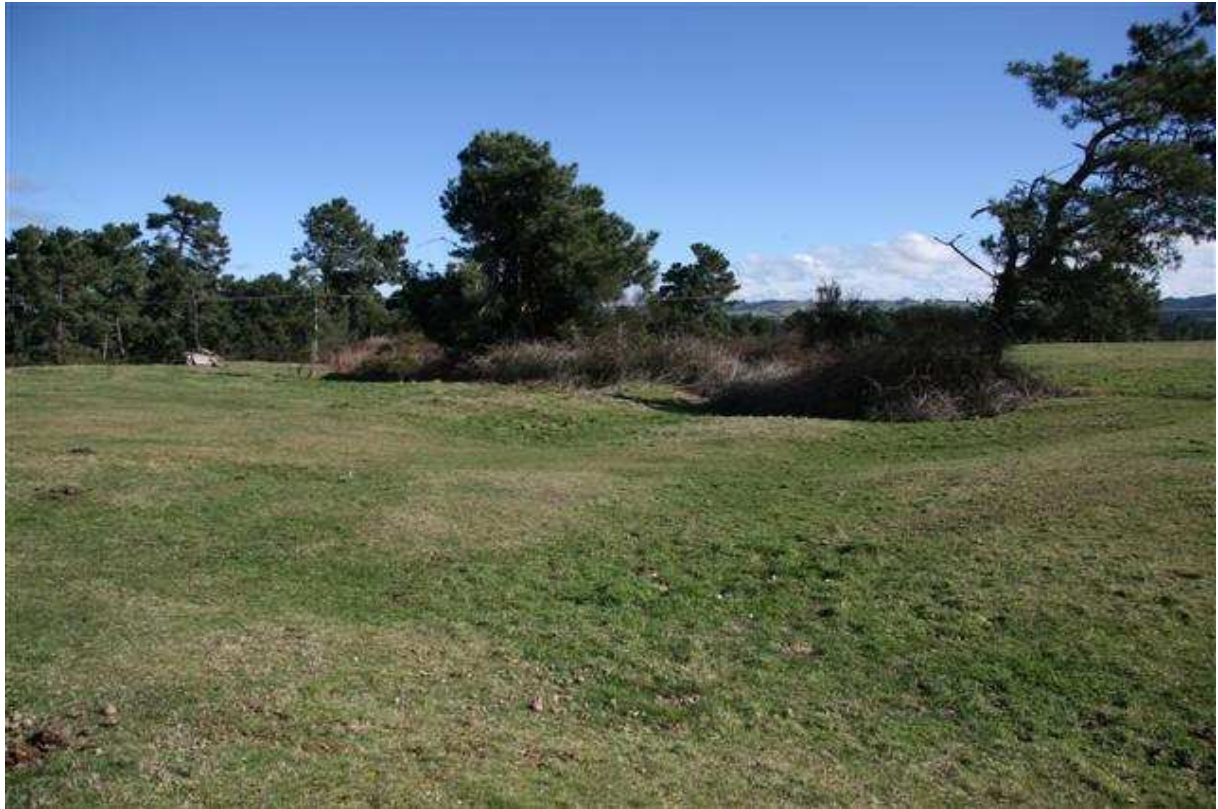
Plate 5: A gully with an ephemeral waterway drains from east to west to the north of Broadlands Road. The vegetation is (maritime pine)/blackberry-broom scrub, adjoining grazed pasture.

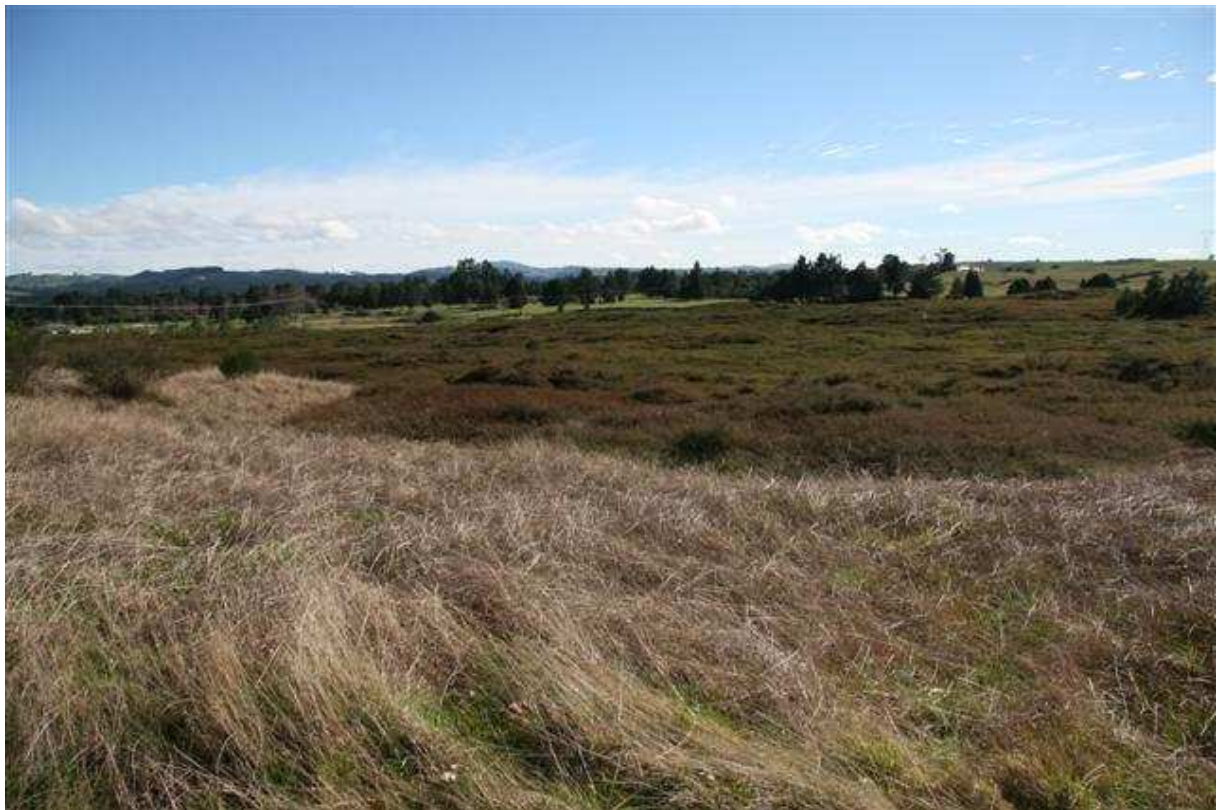
Plate 6: Broadlands Road Scenic Reserve contains an extensive area of prostrate kanuka scrub, a vegetation type characteristic of geothermal habitat.

Threat: The reserve is currently relatively inaccessible to the general public, which has limited the damage caused by people trampling on vegetation. Geothermal vegetation is particularly vulnerable to trampling damage. Informal tracking is evident at many other geothermal locations, where people have walked through geothermal vegetation, particularly in prostrate kanuka scrub and shrubland. Trampling can also cause compaction of geothermal soils.

Management: Establish a barrier (fence) and buffer between any development and the reserve to prevent access by people on foot and in vehicles.

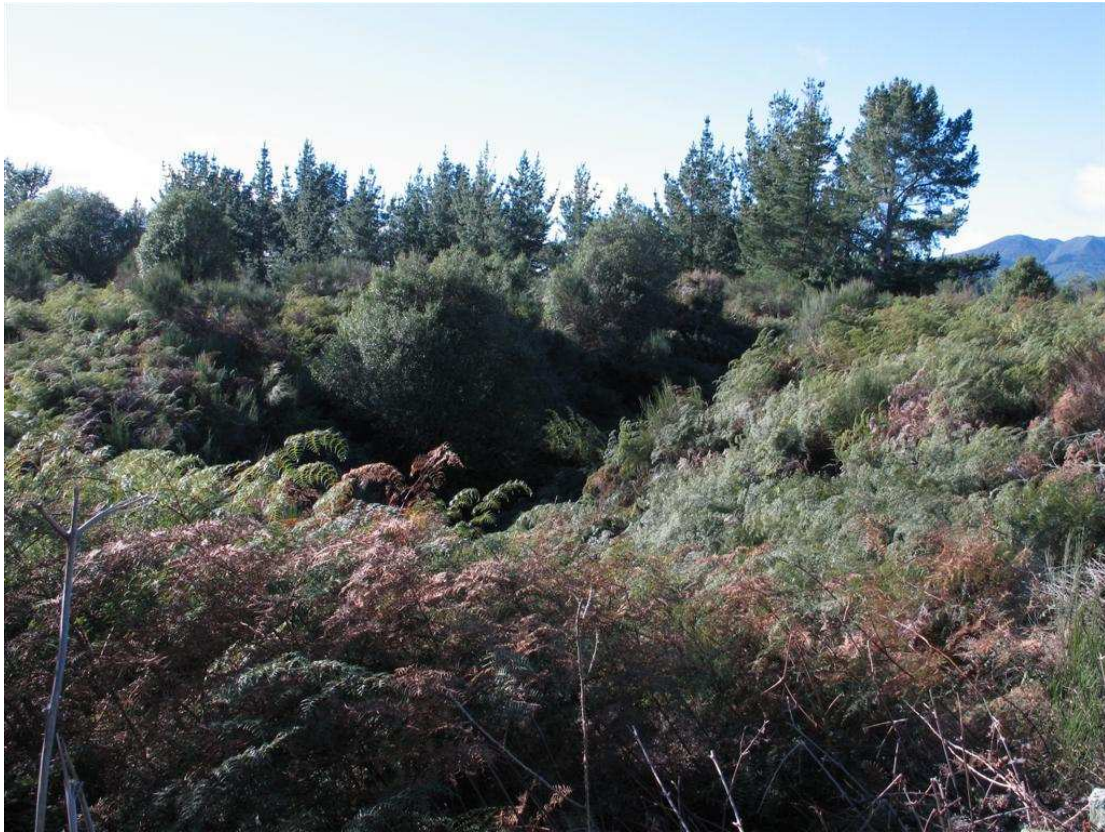
Plate 7: Deeply-incised gully in Taupo Airport Block, with maritime pine forest in background and bracken-blackberry scrub in foreground. These gullies are surrounded by pasture.

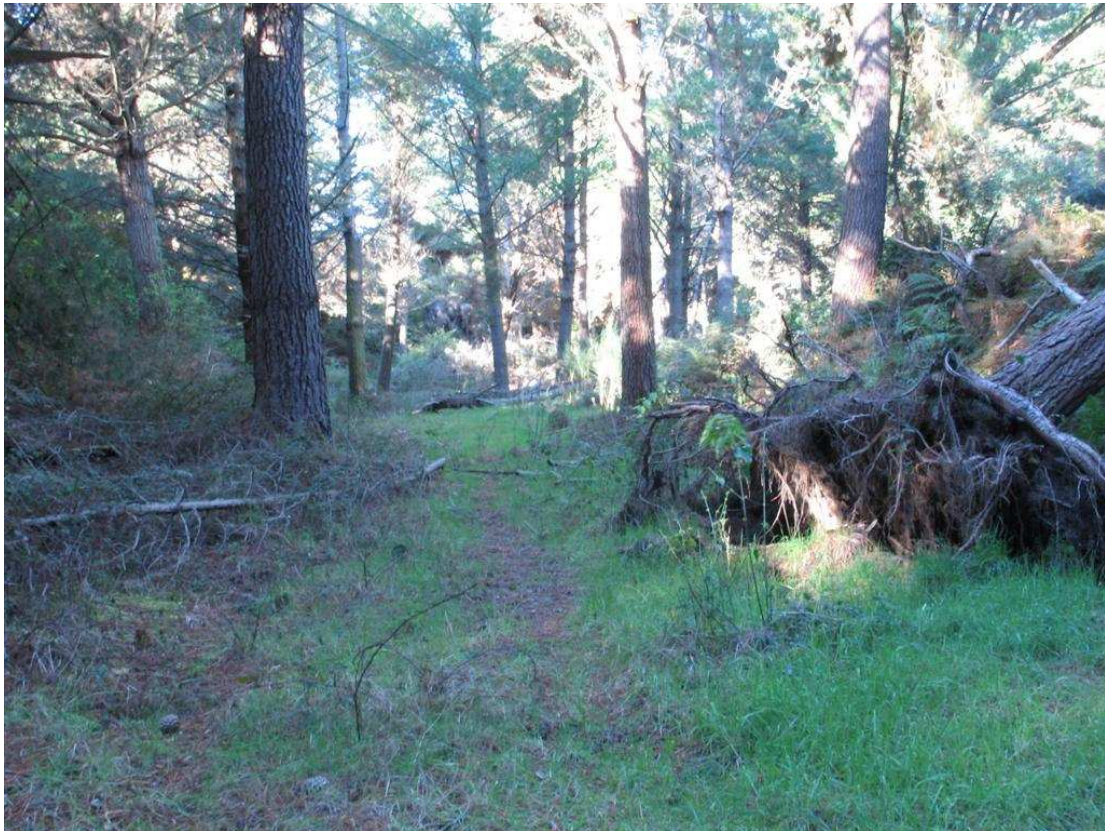
Plate 8: Floor of gully shown in Plate 7, contains rank exotic grasses.

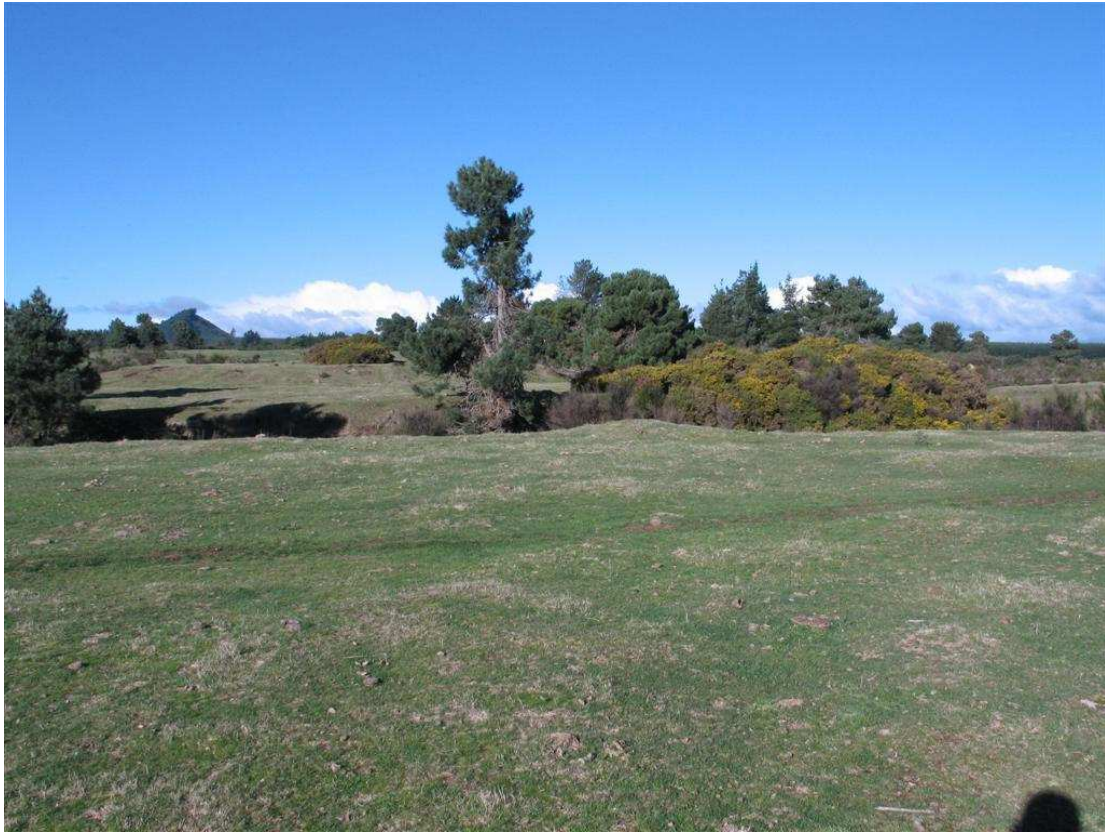
Plate 9: Pasture typical of most of the Taupo Airport block, with many ephemeral flow gullies surrounded by broom and gorse scrub and shrubland. Note the scattered maritime pines.

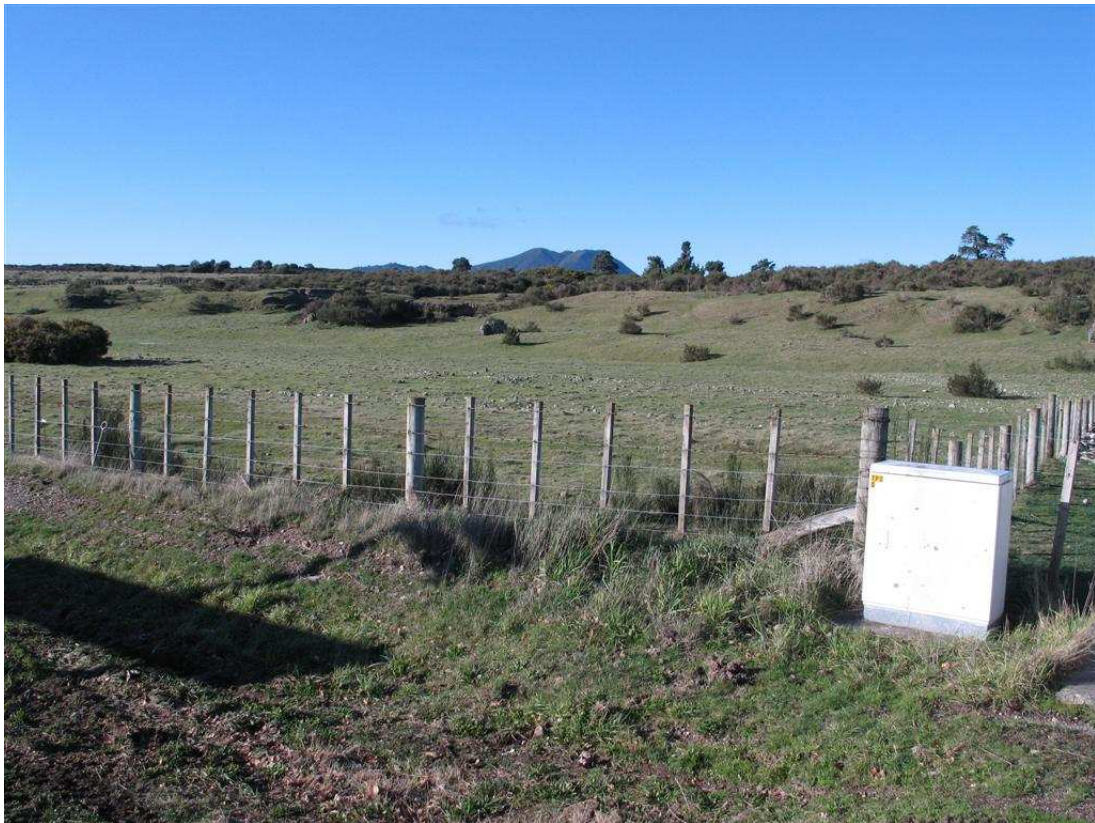
Plate 10: Overview of southern part of the Taupo Airport Block, which is mostly pasture with broom and gorse common.

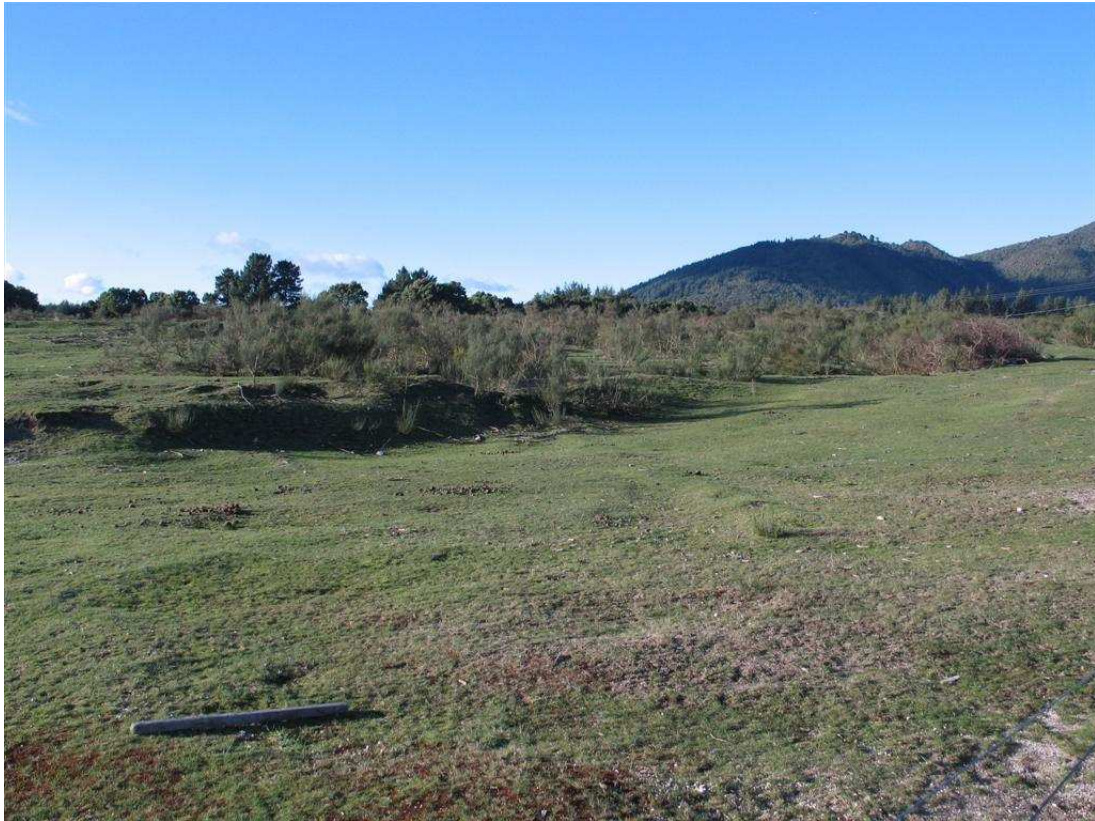
Plate 11: Pasture and broom shrubland and scrub near junction of Napier-Taupo Road and Crown Road.

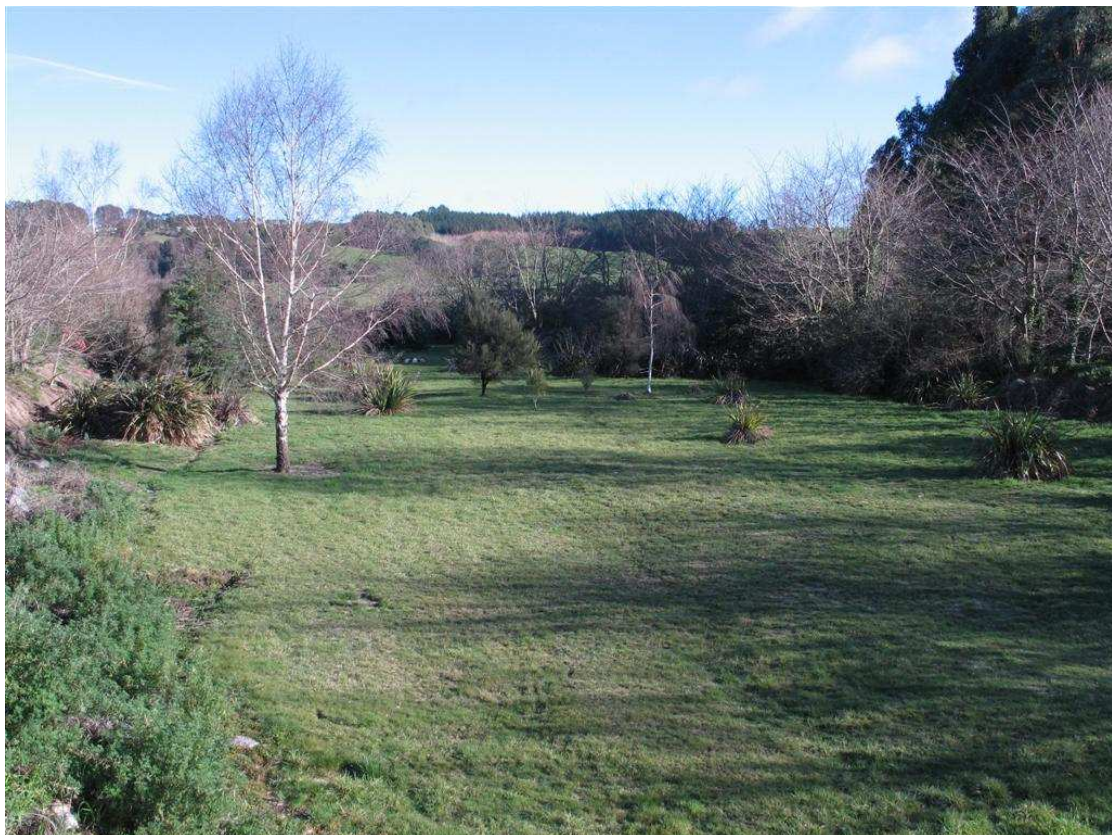
Plate 12: Gully on far western side of the Rangatira E Block. The valley floor contains rank grasses, with mixed plantings of harakeke and silver birch.

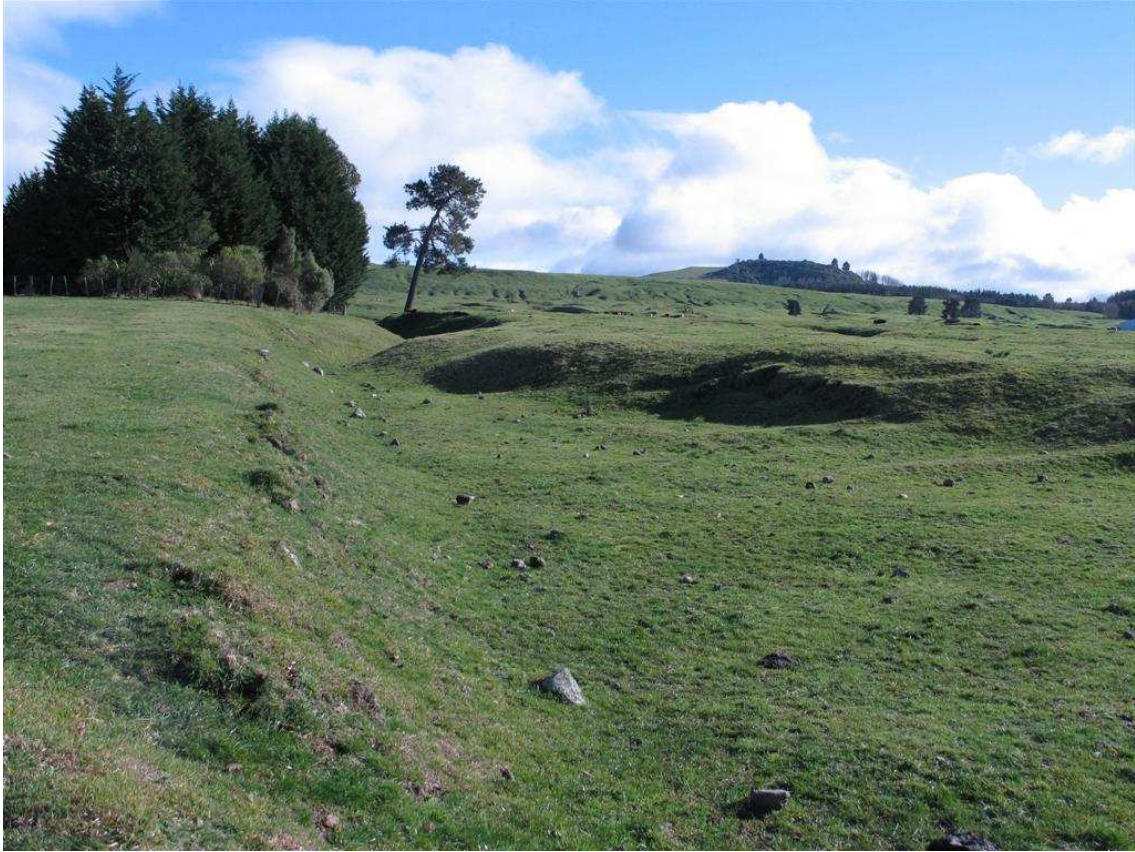
Plate 13: Numerous shallow gullies occur across the Rangatira E Block.

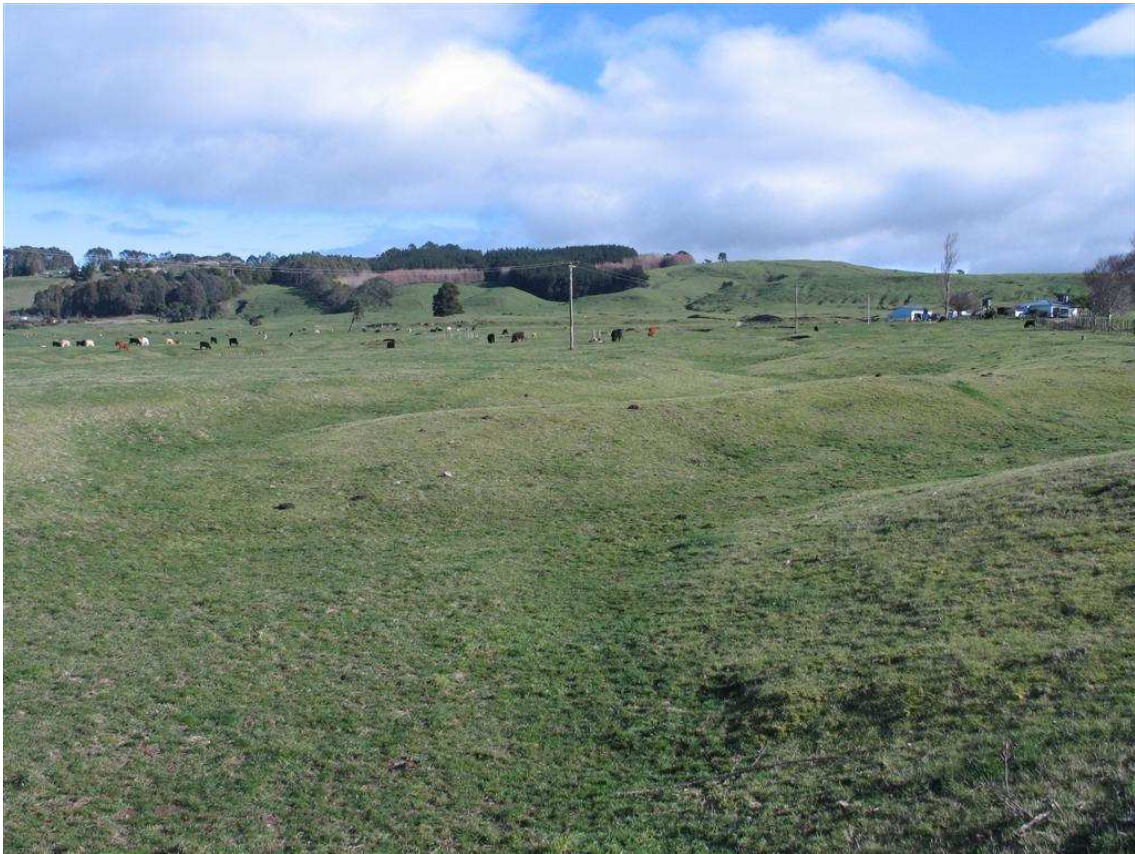
Plate 14: Repeated pattern of shallow gullies at the Rangatira E Block.

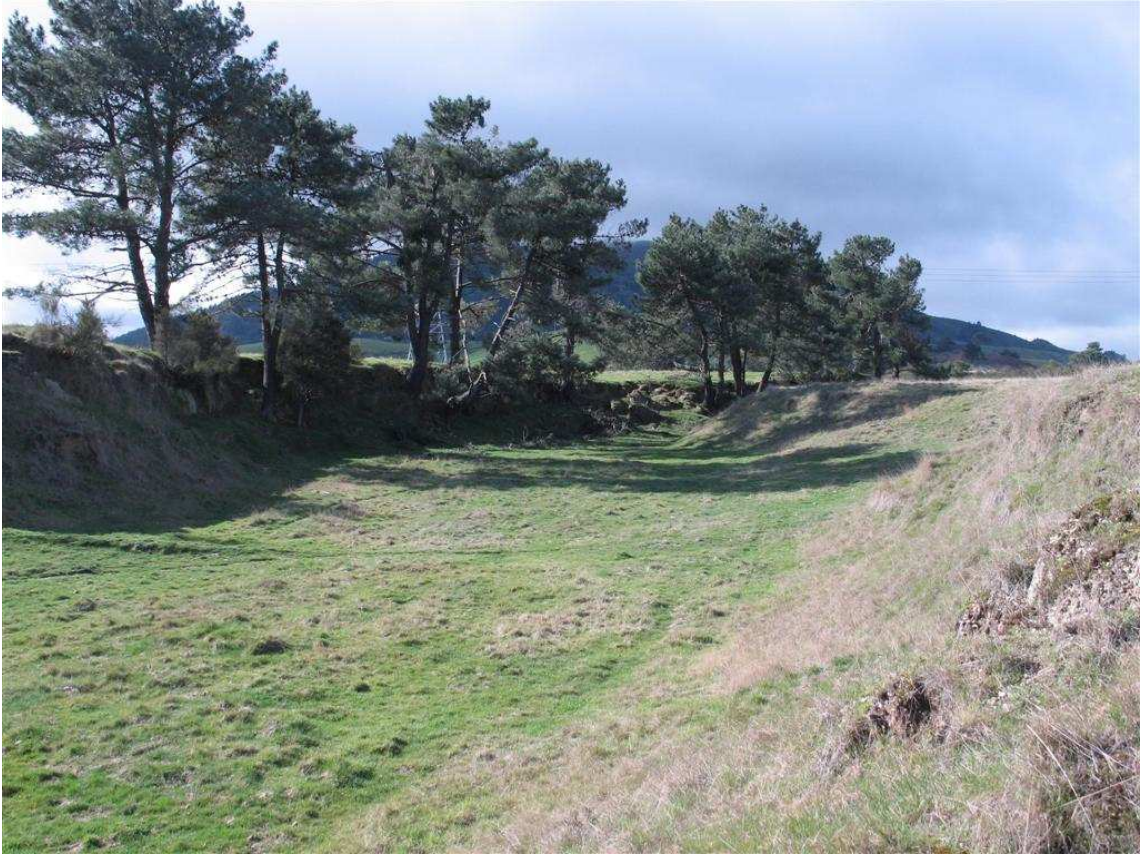
Plate 15: An ephemeral gully system to the south of Broadlands Road.

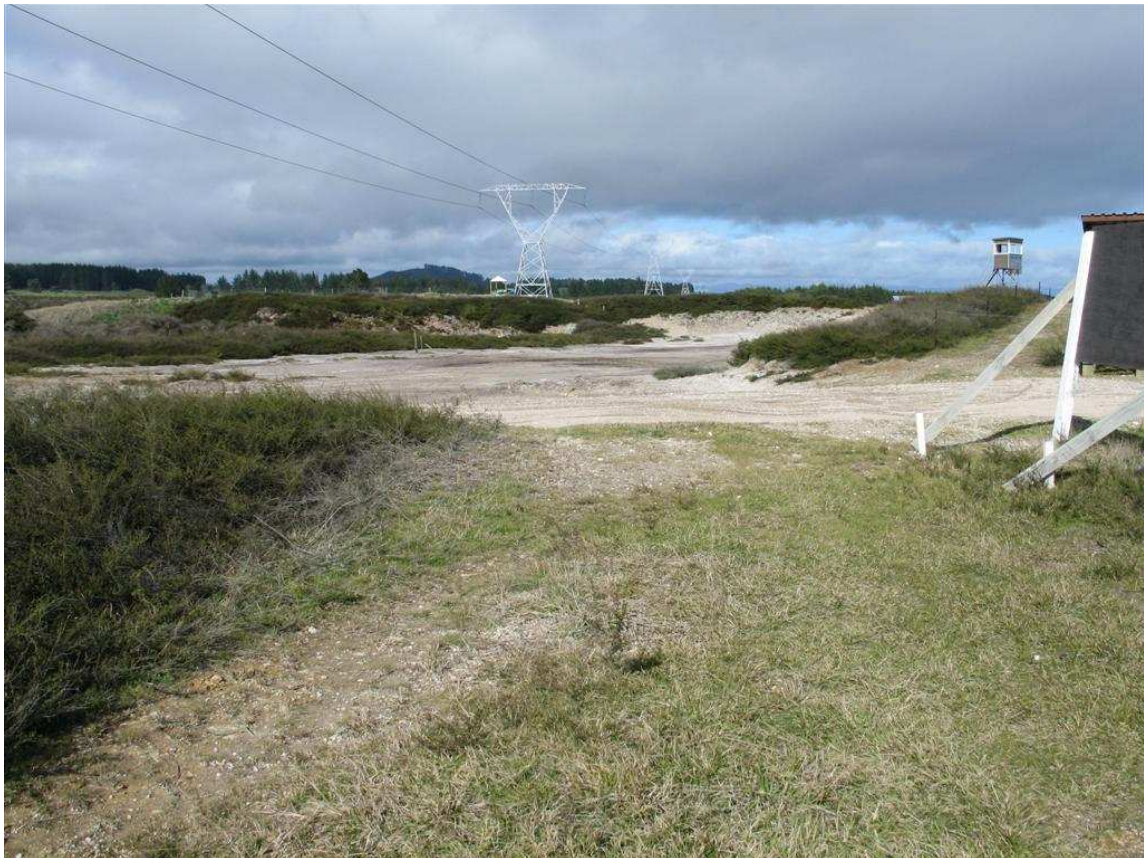
Plate 16: Prostrate kanuka scrub at motorcycle track at Crown Road.

Threat: Geothermal vegetation - particularly species such as prostrate kanuka and monoao - is especially vulnerable to fire. There is a risk of wild fire caused by discarded cigarette butts thrown by people constructing or utilising the industrial development site. Fire has recently been a problem at part of the Crown Road site.
