Active fault hazards in the Taupō District

GNS Science Consultancy Report 2020/31
August 2020

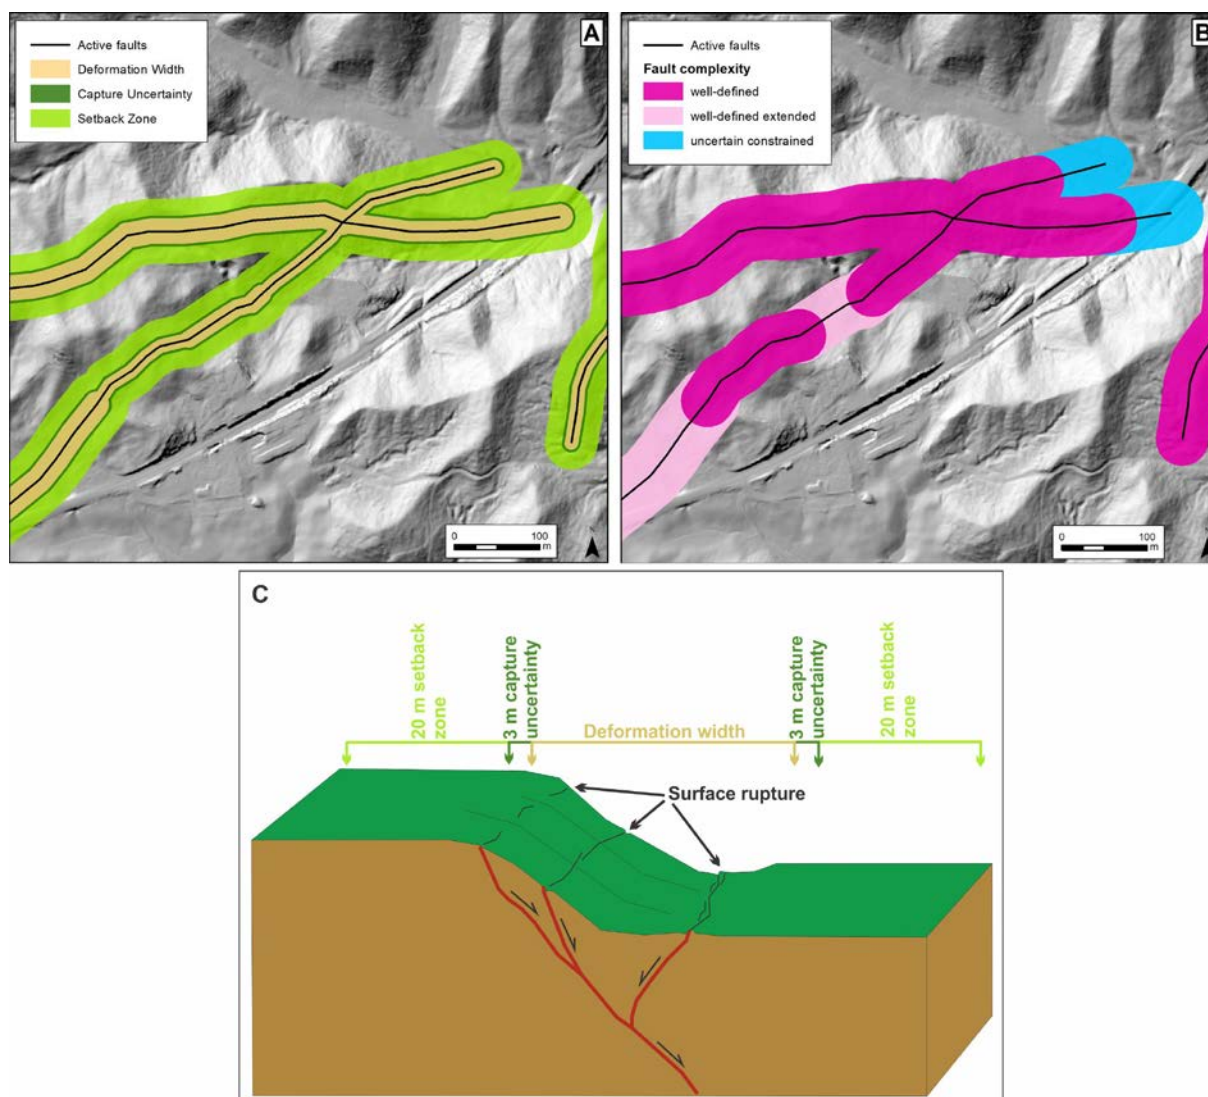
Figure 3.2 Components of the Fault Avoidance Zones. (A) Individual buffer zones used to create Fault Avoidance Zones. (B) The resulting Fault Avoidance Zones classified by fault complexity. (C) Schematic block diagram showing how the buffer zones relate to fault features in the field.

Fault Avoidance Zones (polygons) were developed using the following steps (Figure 3.2):

1. Buffer the active fault trace (black lines in Figure 3.2A, C) by the Deformation Width (light orange in Figure 3.2A, C). This forms the 'Likely fault rupture zone' in the MfE Active Fault Guidelines (Kerr et al. 2003). In the Taupō Rift, the fault is considered to most likely be in the centre of the fault scarp, so the buffer zones are symmetrical about the fault lines.

3. Buffer the faults by the Capture Uncertainty (dark green in Figure 3.2A, C). This accounts for the uncertainty in the exact geographical coordinates of a point or line on a map, given the intrinsic location error derived from the map resolution. A single value of ± 3 m was used, and this value takes into account both the resolution (1–2 m) and the uncertainty in georeferencing LiDAR data.

4. Buffer the Deformation Width and Capture Uncertainty by a further ± 20 m to create what is sometimes referred to as the 'Setback Zone' (light green in Figure 3.2A, C). This additional 20 m accommodates the intense deformation and secondary ruptures that can occur close to primary mapped fault rupture.

The combined zone is the Fault Avoidance Zone (Figure 3.2B), which is classified with the recurrence interval class and fault complexity. Recurrence interval classes are defined in Table 3.3 and are discussed in Section 5.1. Fault complexities are defined in Table 3.2, although, in practise in the Taupō District, all faults were classified either as well-defined (for those with traces visible in the LiDAR data), well-defined extended (for those joining gaps), or uncertain constrained (for those extended beyond the mapped lengths).

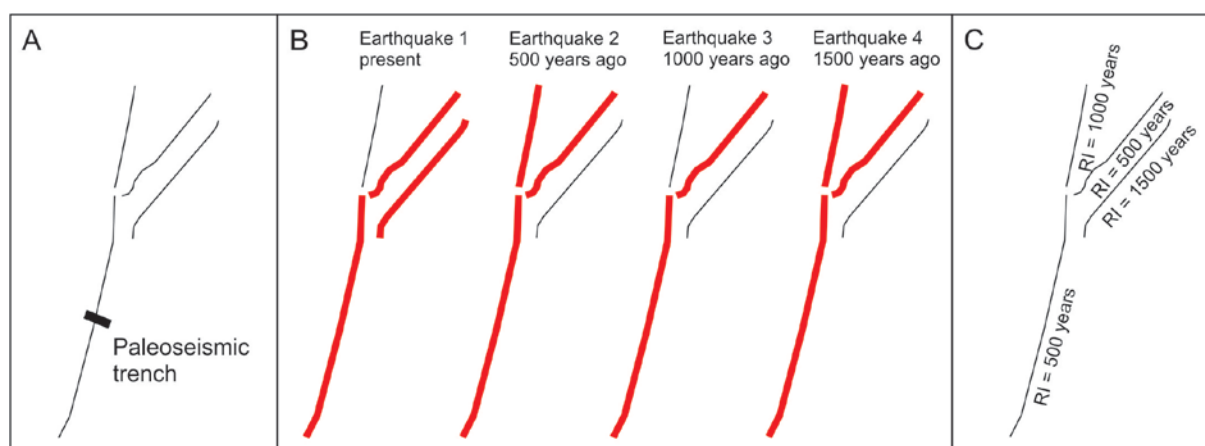
Figure 5.2 Schematic showing how recurrence intervals can vary for different traces on a Taupō Rift fault. (A) Hypothetical paleoseismic trench where past earthquake information is obtained. (B) Specific earthquakes may rupture different combinations of fault traces. (C) Illustrative recurrence intervals (RIs) for individual fault traces. In this hypothetical case – and considering the RI values shown – even though the RI of individual trace may vary considerably (in this case by a factor of 3), all traces would be assigned to RI Class I (≤ 2000 years).

* The ≤2000 years recurrence interval applied to all traces of all named Taupō Rift faults are acknowledged to be a conservative minimum (min.) classification because it is possible that not every fault trace that comprises an entire fault ruptures in every earthquake (Figure 5.2). Therefore, the recurrence interval class for individual fault traces could be much longer (larger) than the fault as a whole.

There are many challenges to assigning recurrence interval classes to each fault and fault trace in the Taupō District. The largest is a lack of data, with no available paleoseismic data for the NIDFB faults and sparse data for the large number of Taupō Rift faults. Another key issue for the multi-trace Taupō Rift faults is that recurrence intervals vary through both time and space. Spatially, not all traces that comprise an entire fault have the same recurrence intervals because not all traces rupture in each earthquake. This is diagrammatically illustrated in Figure 5.2, whereby earthquakes recorded in a hypothetical trench – where the fault is represented by a single trace – may suggest a recurrence interval of 500 years. However, farther along the fault, where the fault may comprise many traces, each of those may only rupture in some earthquakes and therefore may have longer recurrence intervals.

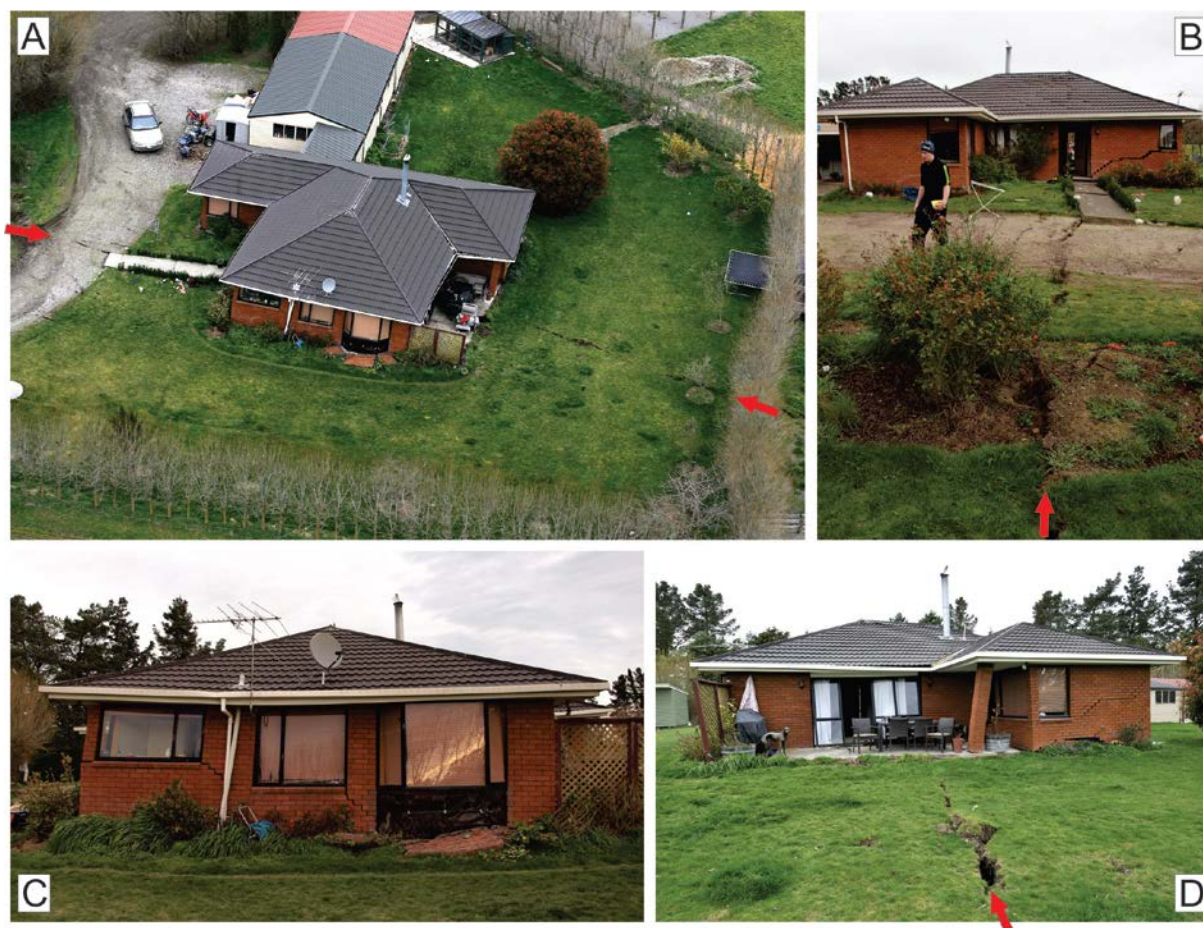
Figure A2.10 Telegraph Road house and Greendale Fault surface rupture; see Figures A2.7 and A2.8 for location. Red arrows denote location of discrete surface fault rupture. (A) Aerial view looking south. Photo by Richard Cosgrove. (B) View looking west-northwest. Photo by Hayden Mackenzie. (C) View looking south-southwest. Photo by Hayden Mackenzie. (D) View looking east-southeast. Photo by Dougal Townsend.

The Telegraph Road house (Figure A2.10) was a timber-framed, brick-clad residential structure with a concrete slab foundation (at most, only lightly reinforced) and lightweight roof. It was located within the Greendale Fault's ground-surface fault rupture deformation zone (~150 m wide at this site) that accommodated a total of 4–5 m of dextral displacement. The house was badly damaged by distributed deformation, and ~0.5 m of discrete strike-slip rupture that entered the house through the front door (Figure A2.10B) passed through the house's foundation (including living room) and exited through the back door (Figure A2.10D).

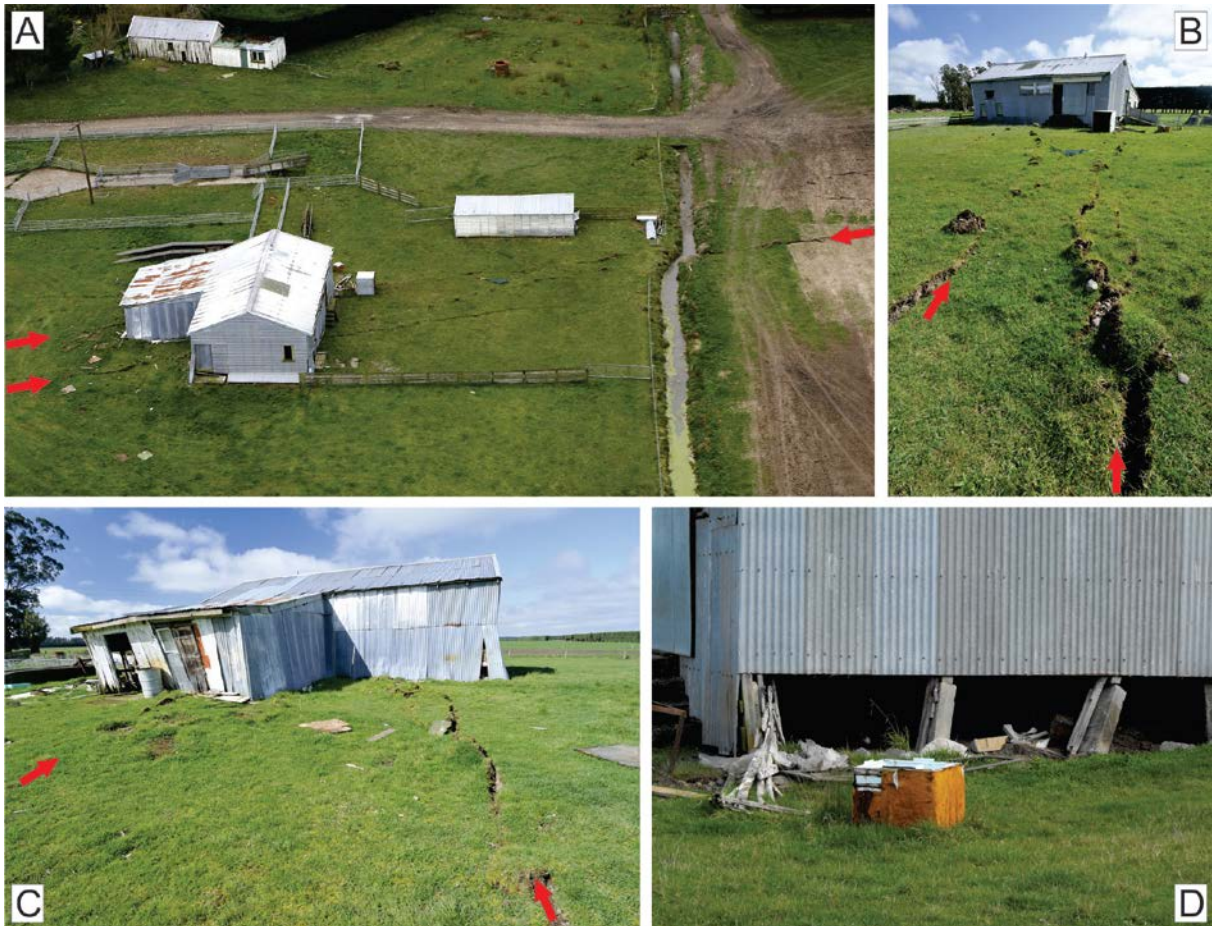
Figure A2.11 Kivers Road woolshed and Greendale Fault surface rupture; see Figures A2.7 and A2.8 for location. Red arrows denote location of discrete surface fault rupture. (A) Aerial view looking northeast – note dextral offset of irrigation channel in right-hand side of photograph. Photo by Richard Cosgrove. (B) View looking west. Photo by Dougal Townsend. (C) View looking east. Photo by Dougal Townsend. (D) View looking southwest showing detail of shallow-seated concrete piles. Photo by Russ Van Dissen.

The Kivers Road woolshed was a timber-framed structure located within a 25–50-m-wide ground-surface fault rupture deformation zone of the Greendale Fault. At this site, surface fault rupture deformation comprised both discrete shears and distributed deformation and accommodated ~2.7 m of net slip (predominantly strike-slip) (Figure A2.11). The woolshed was made up of two parts, a larger metal-clad structure with a timber floor founded on shallow-seated ~700-mm-high concrete piles (Figure A2.11D) and a smaller lean-to structure attached to the side (Figure A2.11A, C). The lean-to was a pole building (part metal-clad and part wood-clad) with an unreinforced concrete floor. The response of the two different construction styles to surface fault rupture was noticeably different. The support poles of the lean-to were set into the ground; dextral fault rupture under the lean-to led to lateral displacement of the support poles on either side of the rupture and significant distortion of the walls and roof (Figure A2.11C). In contrast, surface rupture deformation under the larger piled structure was, in large measure, isolated from the superstructure by rotation of the shallow-seated piles. The timber flooring and framing and metal cladding proved a resilient structural system that limited internal distortion.

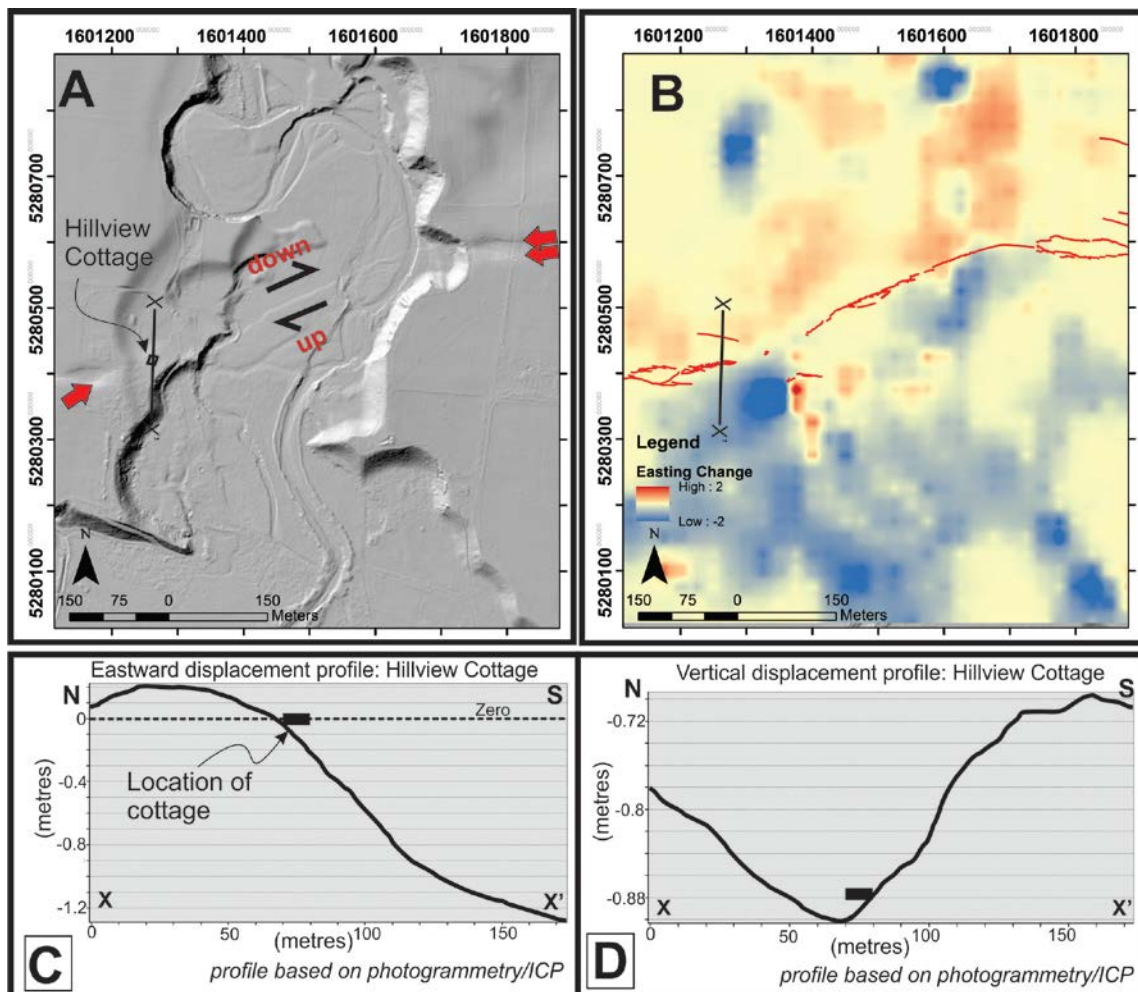
Figure A2.29 Hillview Cottage and The Humps Fault surface rupture. (A) LiDAR hill shade DEM showing location of the cottage within a relatively narrow fault rupture deformation zone (red arrows). (B) Raster of displacement in the east direction (positive is east, negative is west) calculated using ICP method described in text. Some anomalies and artefacts of the grid exist within the dataset, but the overall pattern is one of predominantly dextral displacement. West of the cottage is a small pull-apart, while the 100-m-scale fault geometry is that of a restraining bend. (C, D) The eastward and vertical deformation profiles from X to X', respectively. Y-axis exaggeration in (C) = 60. Y-axis exaggeration in (D) = 385.

Hillview Cottage is located on a zone of concentrated deformation in the central section of The Humps Fault. Just west of the cottage, there is a prominent, ~25-m-wide pull-apart depression that transitions to the east into a narrow zone of Riedel shears and tension fractures
